RE: Folio no.: 28-2210-014-0001, Plaza del Prado Condominium  
18011-18041 Biscayne Blvd South Tower I, II, III, IV  
18051-18081 Biscayne Blvd North Tower I, II, III, IV  
18071 Biscayne Blvd Aventura FL. 33160  
Notice of Required Recertification 40 Year Building  
Y:\Clients\Falcon2016\16-637\013\_40 Year Recertification\Structural\L210803- 40 Year Recertification Cover Letter.Doc

# 40-YEAR CERTIFICATION

## STRUCTURAL/ELECTRICAL 40-YEAR RECERTIFICATION

## EXHIBIT I

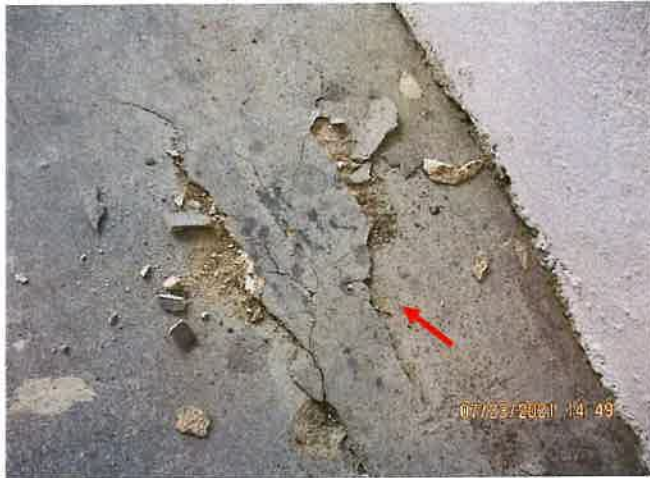
TW1N

**Picture 1: Typical Concrete Spalling Stairway Landing.**

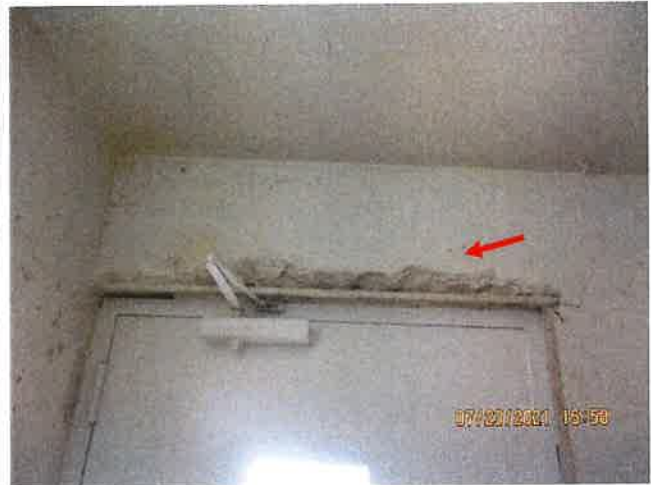
TW2N

**Picture 2: Concrete Spalling and exposed rebar at exterior stairway door header.**

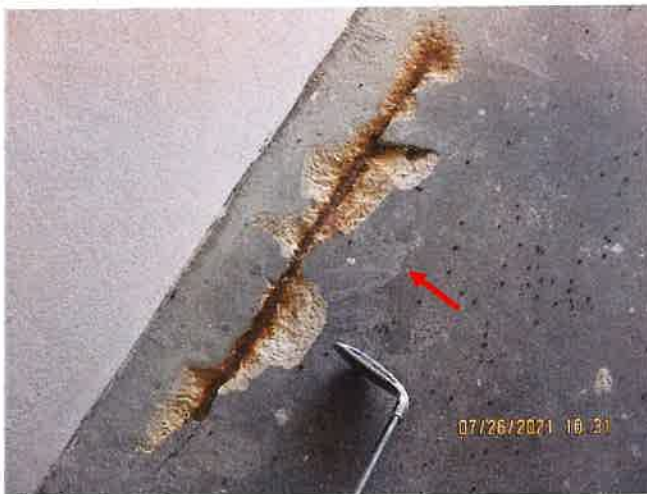
TW4N

**Picture 3: Concrete Spalling and exposed corroded rebar at exterior stairway landing floor.**

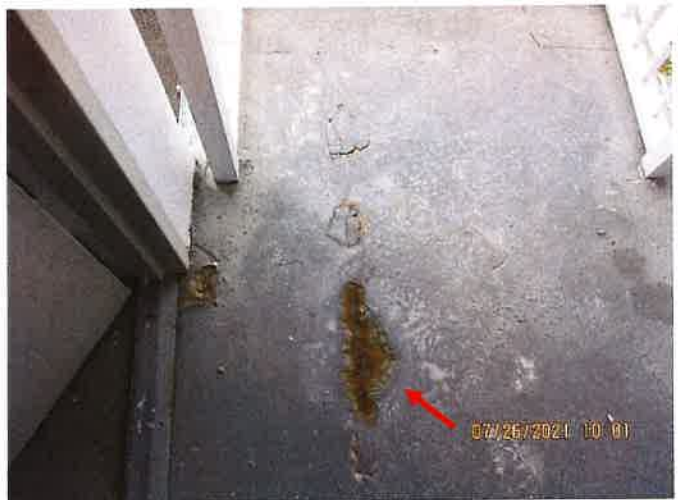
TW4N

**Picture 4: Concrete Spalling and exposed corroded rebar at exterior stairway landing floor.**

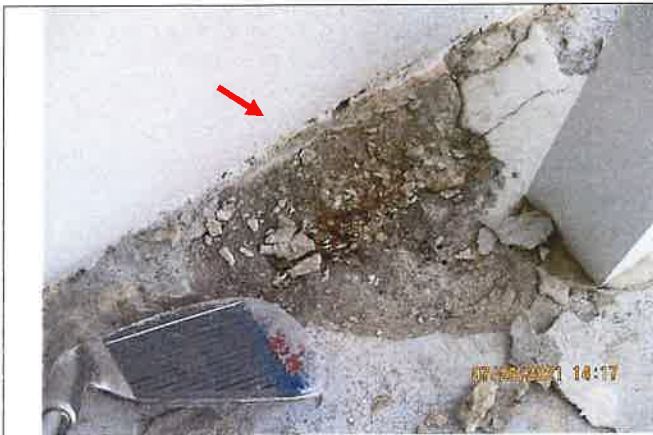
TW1S

**Picture 5: Concrete Spalling and exposed corroded rebar at exterior stairway landing floor.**

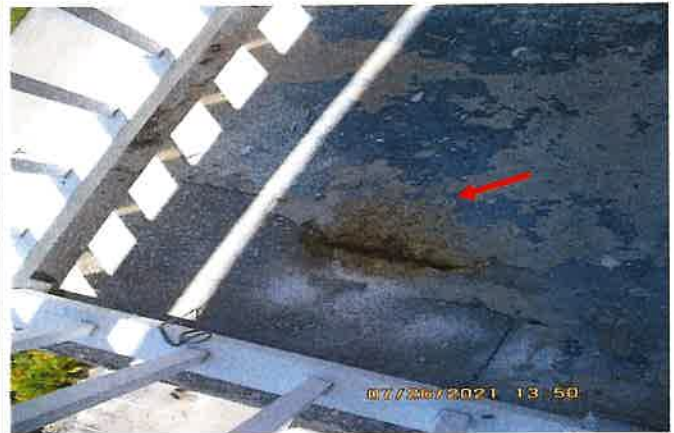
TW2S

**Picture 6: Concrete Spalling and exposed corroded rebar at exterior stairway landing floor.**

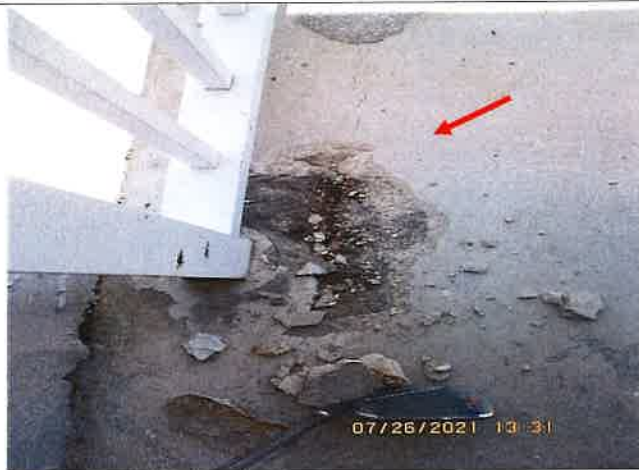
TW3S

**Picture 7: Concrete Spalling and exposed corroded rebar at exterior stairway landing floor.**

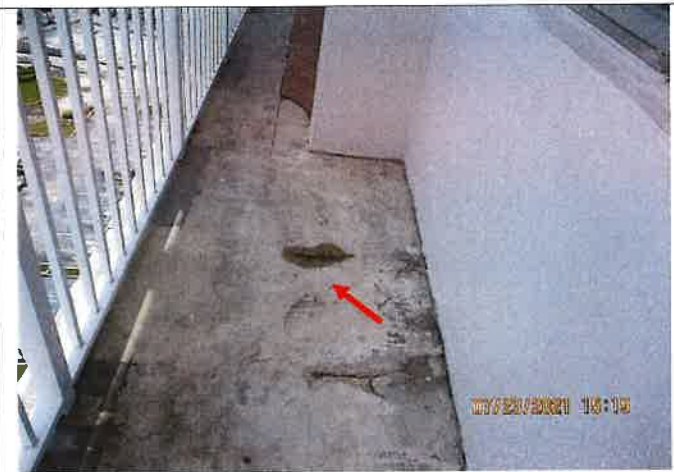
TW2N

- 1) Floors 14 and 19 ponding water at south stairway exterior landing.
- 2) Floor 18 exterior catwalk / crossover observed with concrete spalling, cracks and exposed corroded rebar. Corroded exterior door frames floors 7, 12 and 18 were noted as well.
- 3) Corroded exterior door frames south stairway all floors.
- 4) Concrete spalling and exposed corroded rebar at floor 4 south stairway exterior landing.
- 5) Unit 301, 504, with Tile floor finish, no visible structural issues.

**Picture 8: Concrete Spalling and exposed corroded rebar at exterior catwalk / crossover floor.**

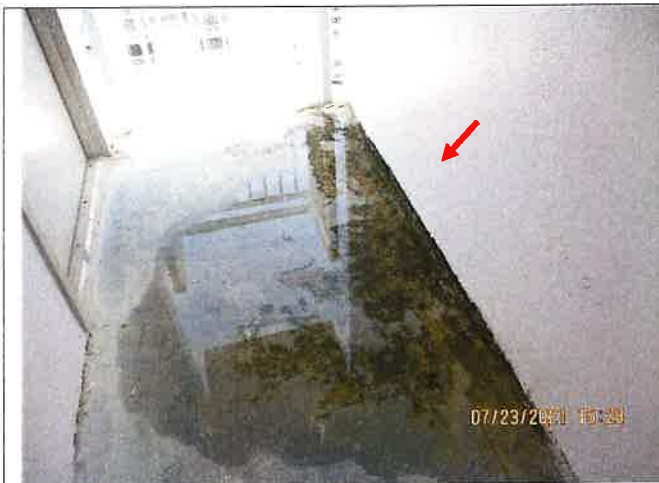
TW2N

**Picture 9: Ponding water and biological growth observed at exterior stairway landing floor.**

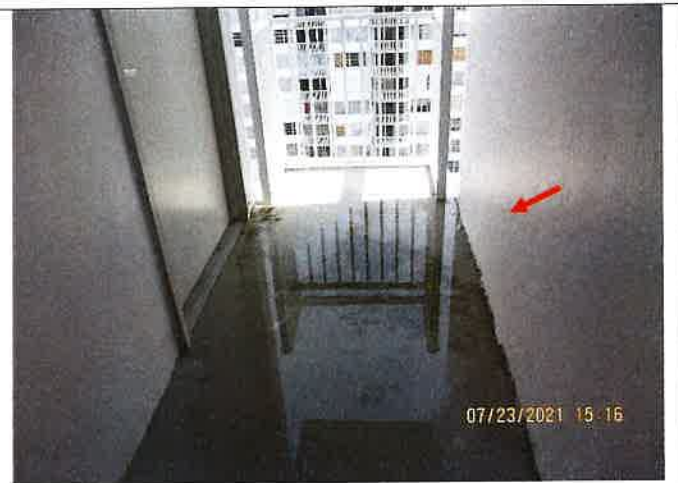
TW2N

**Picture 10: Ponding water and biological growth observed at exterior stairway landing floor.**

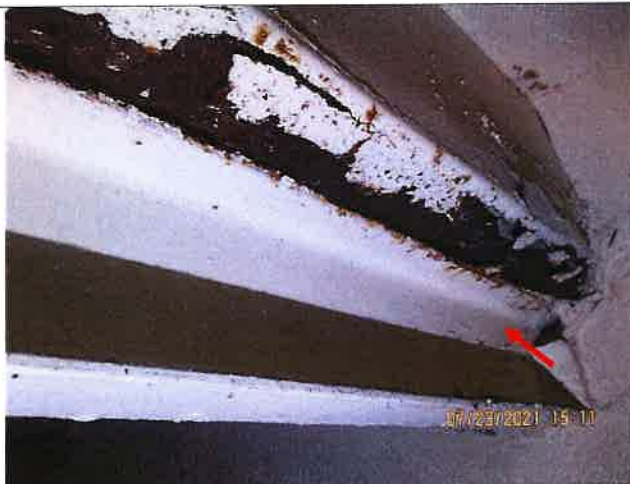
TW1N

**Picture 11: Severely corroded Steel stairway thread and riser condition.**

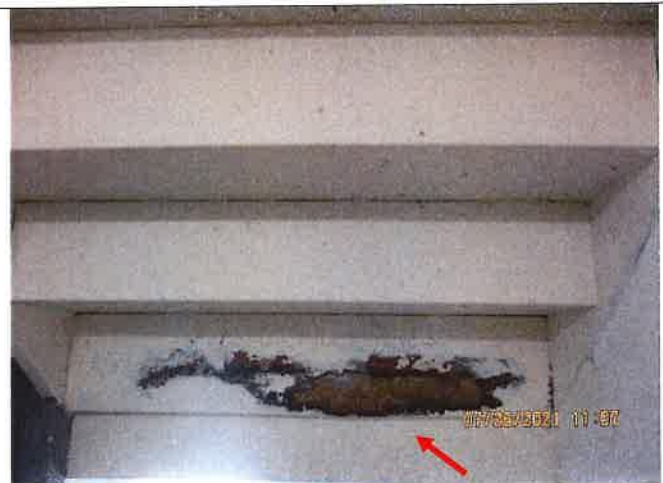
TW4S

**Picture 12: Severely corroded Steel stairway thread and riser condition.**

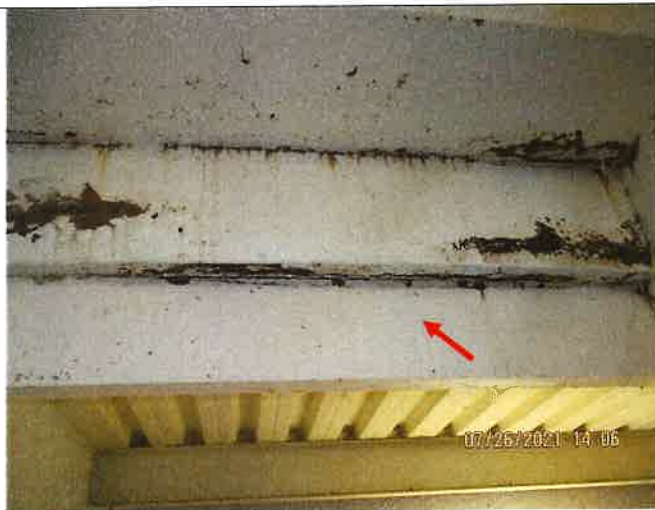
TW15

**Picture 13: Severely corroded Steel stairway thread and riser condition.**

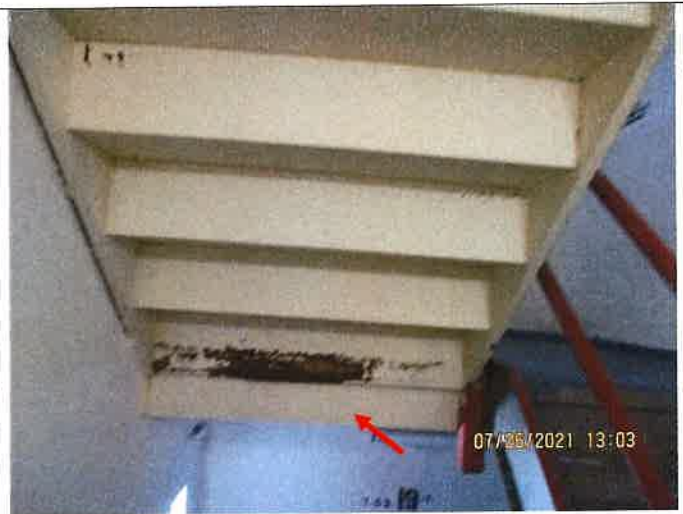
TW35

**Picture 14: Severely corroded Steel stairway thread and riser condition.**

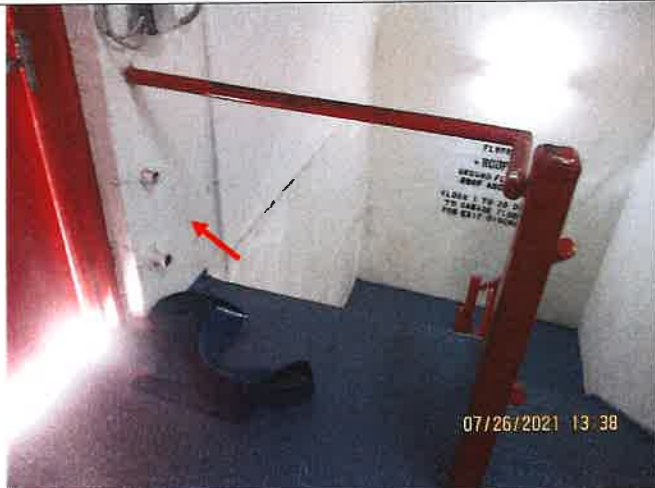
TW25

- 1) Missing stairway railing at south stairway heading to roof area.
- 2) Corroded Stair Steel Steps Floors 19 and PH south stairways.
- 3) Corroded exterior door frames south stairway all floors and at floor 18 catwalk / crossover.
- 4) Floor PH ponding water at south stairway exterior landing.
- 5) Concrete spalling and exposed corroded rebar at floor 11 south stairway exterior landing.
- 6) Unit 703,904,1501,1701 tile floor finish, no visible structural issues.

**Picture 15: Missing stairway guardrail.**

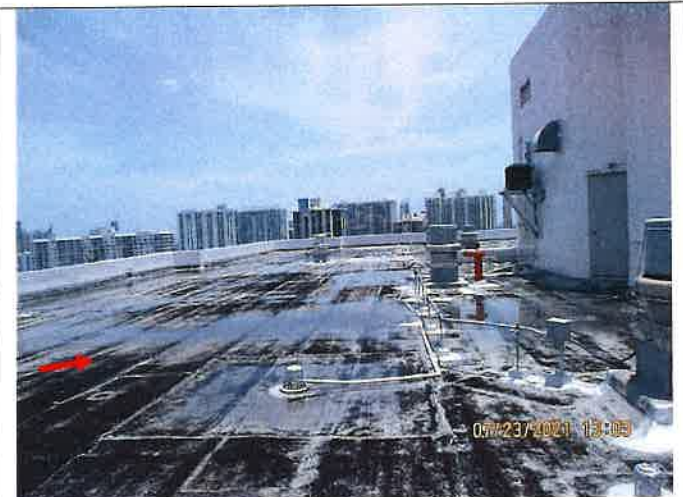
North Roof

- 1) Flat roof membrane / built up roof system observed with ponding water and biological growth.
- 2) Bubbling / Blistering of roof membrane.
- 3) Heavily corroded cooling tower Steel Supports and connections.
- 4) Concrete spalling, cracks and exposed corroded rebar cooling tower enclosure.
- 5) Concrete spalling, cracks and exposed corroded rebar air handling unit room enclosure.

**Picture 16: Ponding water and bubbling / blister observed at roof.**

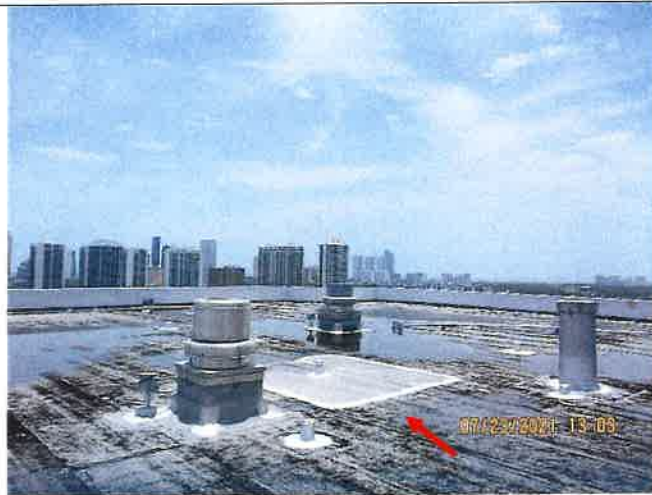
North Roof

**Picture 15: Previous signs of repair at Roof.**

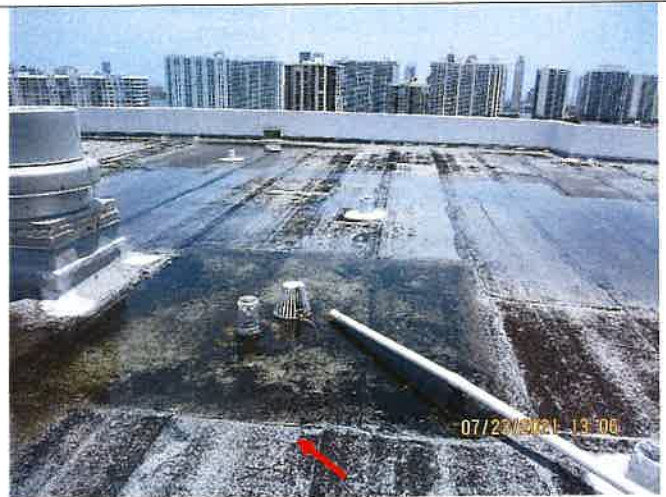
North Roof

**Picture 16: Ponding water, biological growth and poor drainage at roof observed.**

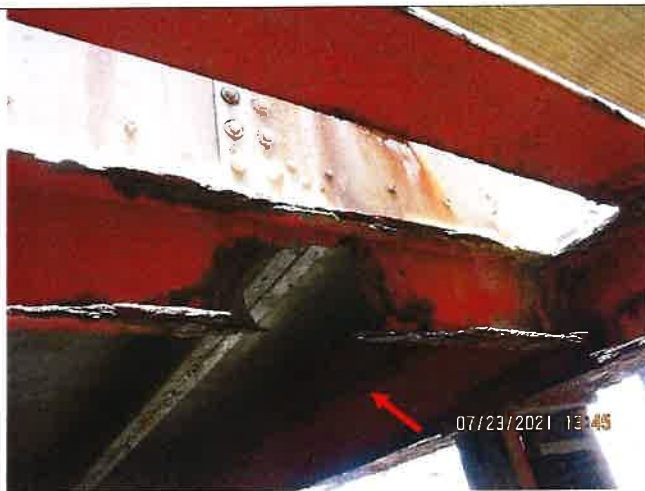
North Roof

**Picture 17: Corroded Steel support cooling tower.**

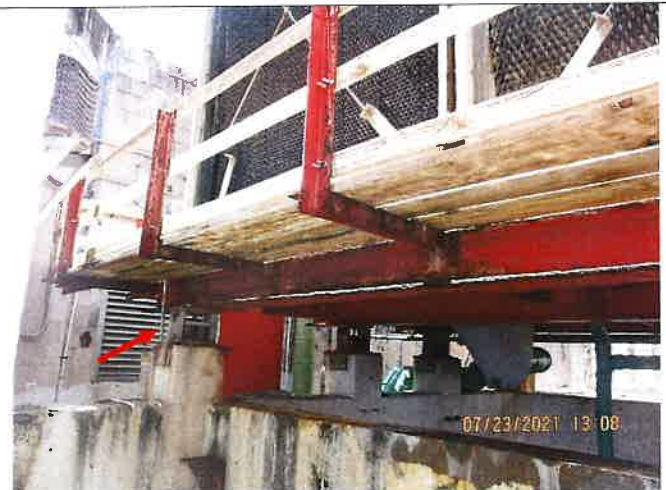
North Roof

**Picture 18: Corroded Steel support cooling tower.**

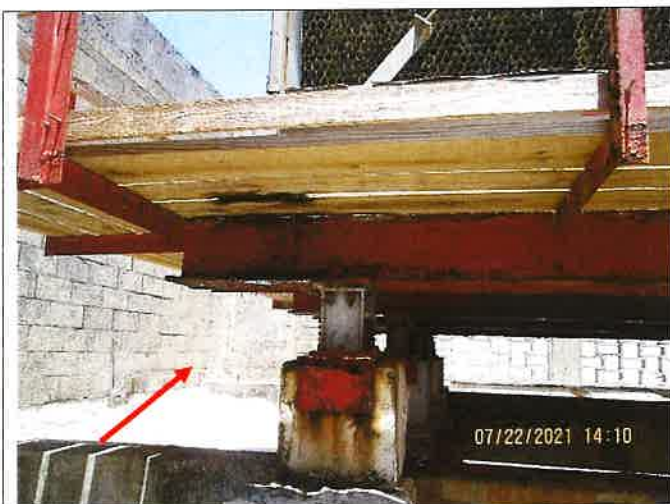
South Roof

**Picture 19: Corroded Steel support cooling tower.**

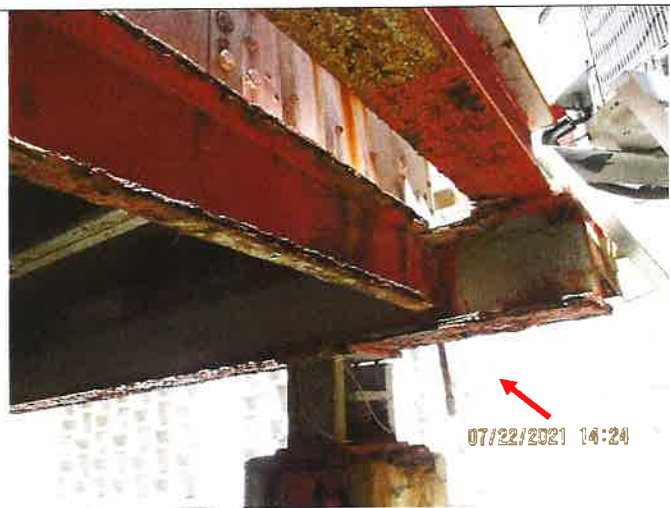
South Roof

**Picture 20: Corroded Steel support cooling tower.**

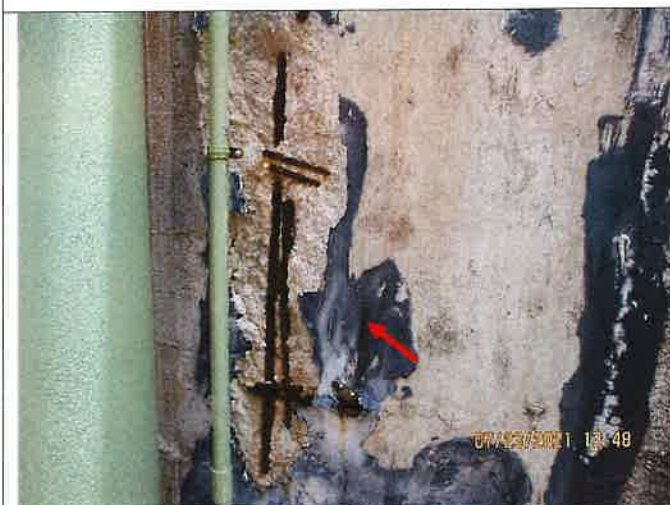
North Roof

**Picture 21: Concrete spalling, exposed corroded rebar at cooling tower enclosure.**

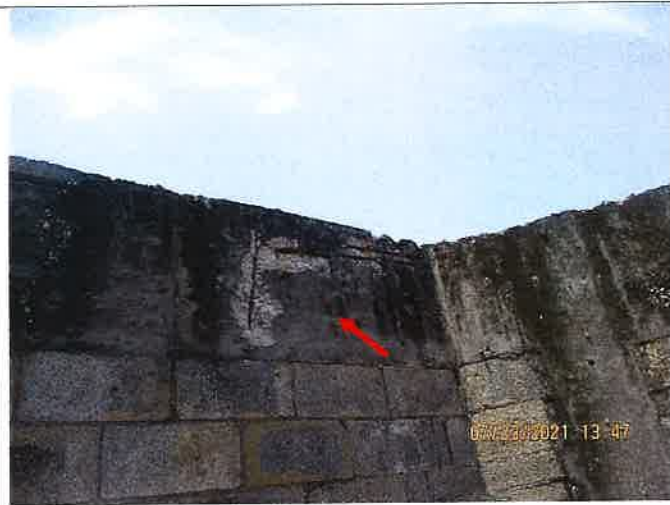
North Roof

**Picture 22: Concrete spalling, exposed corroded rebar at cooling tower enclosure.**

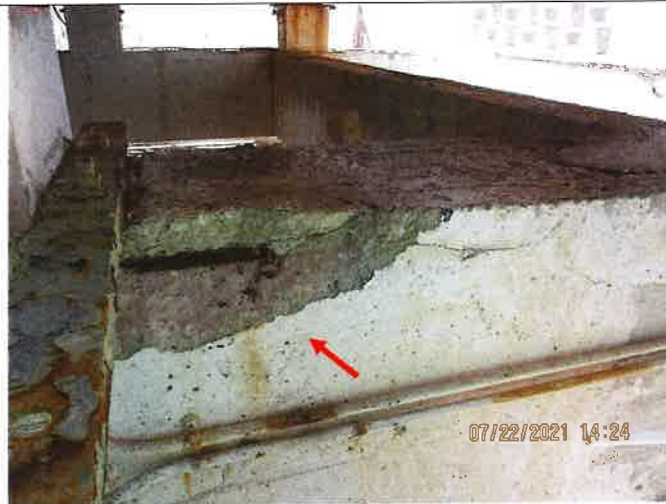
South Roof

**Picture 23: Concrete spalling, exposed corroded rebar at cooling tower enclosure beam supports.**

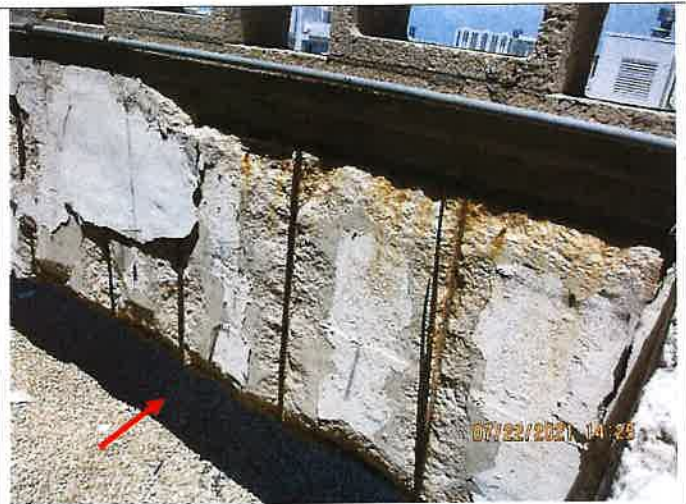
South Roof

**Picture 24: Concrete spalling, exposed corroded rebar at cooling tower enclosure beam supports.**

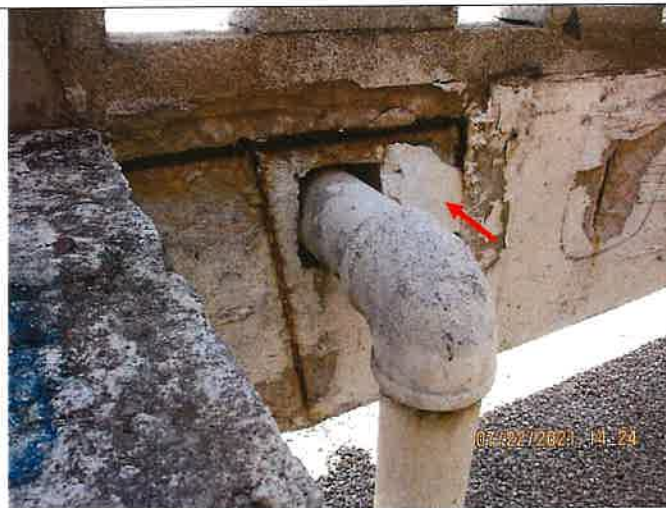
South Roof

**Picture 25: Concrete spalling, exposed corroded rebar at cooling tower enclosure beam supports.**

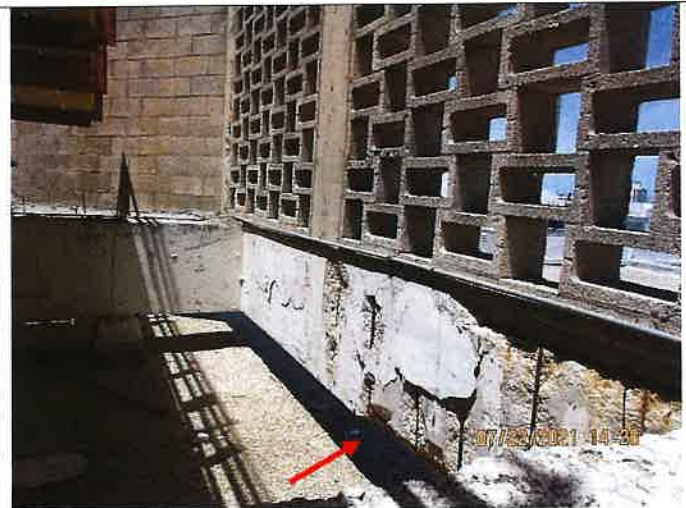
South Roof

**Picture 26: Concrete spalling, exposed corroded rebar at cooling tower enclosure beam supports.**

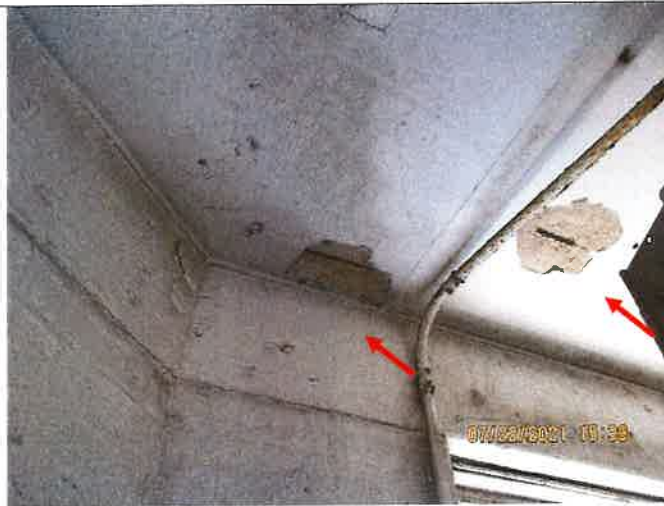
South Roof AHU4

**Picture 27: Concrete cracks, spalling and exposed corroded rebar observed at south roof air handling unit enclosure.**

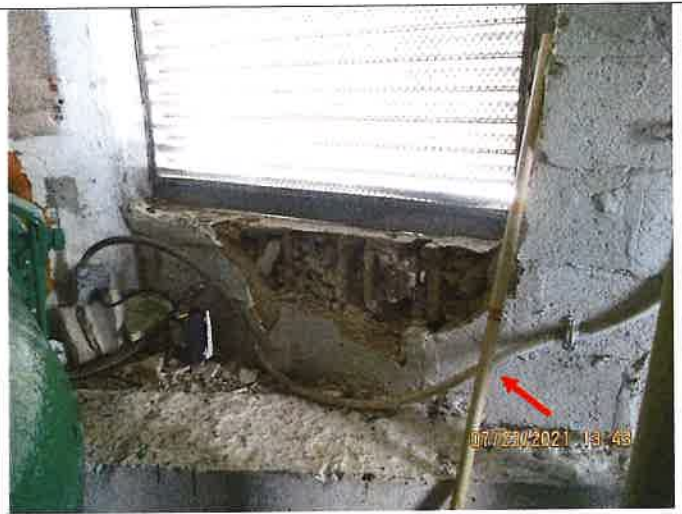
NORTH Roof AHU2

**Picture 28: Concrete cracks, spalling and exposed corroded rebar observed at south roof air handling unit enclosure.**

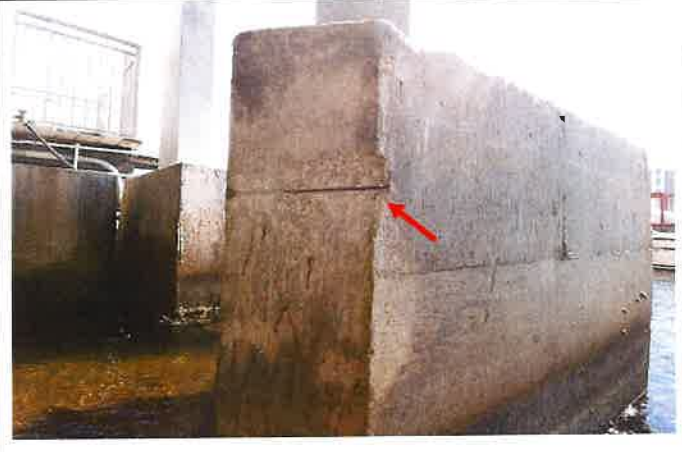
- 1) Minor concrete spalling at pile cap edge of the underwater structure, north building, patching will suffice.
- 2) Marine and Biological growth observed.

**Picture 30: Concrete spalling and exposed rebar observed.**

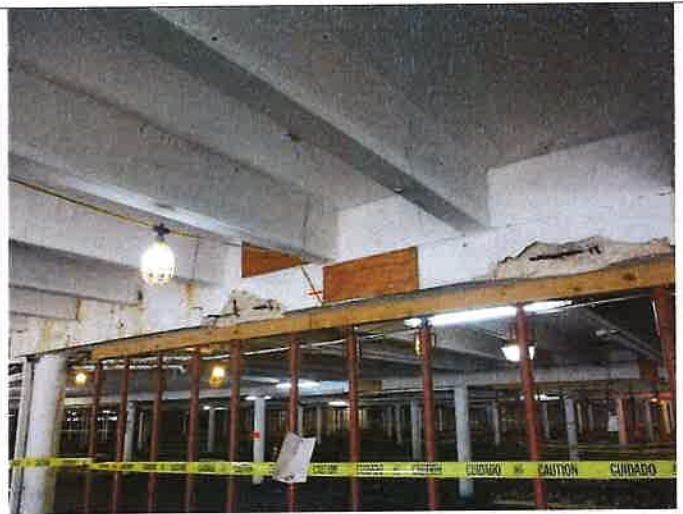
Picture 32 Plaza Del Prado West Deck and Garage observed with concrete spalling and exposed corroded rebar.
