Plaza Del Prado Condominium Association Inc.
18051 Biscayne Boulevard
Aventura, FL-33160

West Parking Garage Repaired Concrete Inspection
Phase I & Phase II

Narrative Statement wrt/ Concrete Repairs

Name: <u>Marcos Valdes</u>	Report Number: <u>06</u>
Client Name: <u>Plaza del Prado</u>	Visit Date: <u>12/03/2024</u>
Project Name: <u>Garage Deck Storm Drainage</u>	Visit Time: <u>01:00 PM</u>
Project Number: <u>16-637-031</u>	Ref: <u>None</u>

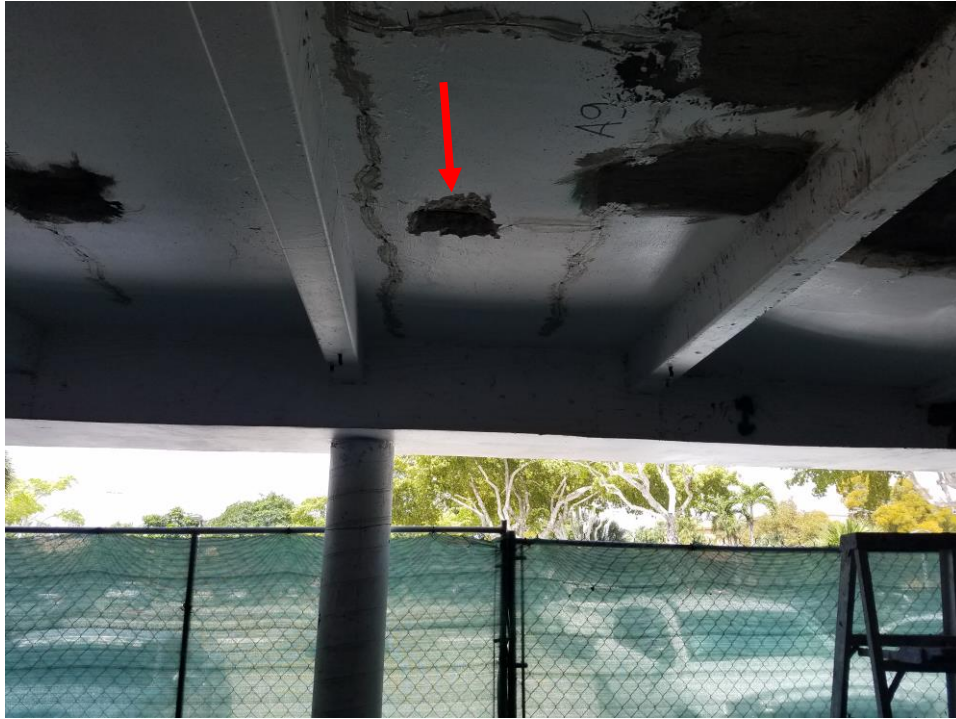
A section of garage overhead slab was demolished at a previous repair site to expose the repaired concrete, the existing (original) concrete surface at the repair site, the interface of the original concrete surface and the repair concrete, and the steel reinforcement inside the overhead slab.

Based on the visual observations, it seems apparent that the exposed reinforcement inside the overhead slab was corroded at the time of our investigation & inspection, with a thick oxidized steel layer that appears to be the un-cleaned, untreated, corroded steel that caused the cracking &/or spalling at this damage site (refer to the “Cause of Reinforced Concrete Deterioration” section above). It also seems apparent that the corroded steel continues further into the concrete slab than the area that was opened up during demolition for this repair.

Photo 1: Slab Repair Location where demolition was performed

For this repair, we would in part require 1) “chasing” of the steel corrosion at the demolition site requiring opening a further area of the concrete slab than was here demolished during the repair, 2) mechanical removal of the oxidized steel by-product down to clean steel, 3) doweling additional steel if required for cross-section tensile steel strength, 4) surface preparation of the corroded steel and the application of an approved bonding agent / primer / rust inhibitor to the steel, 5) use of an approved special-purpose repair concrete containing inhibitor(s) and specified, controlled, moisture content. It thus seems apparent that this repair was not performed in accordance with generally accepted standards &/or applicable Codes & Standards (refer to the “Repair Methods for Deteriorated Reinforced Concrete” section above).

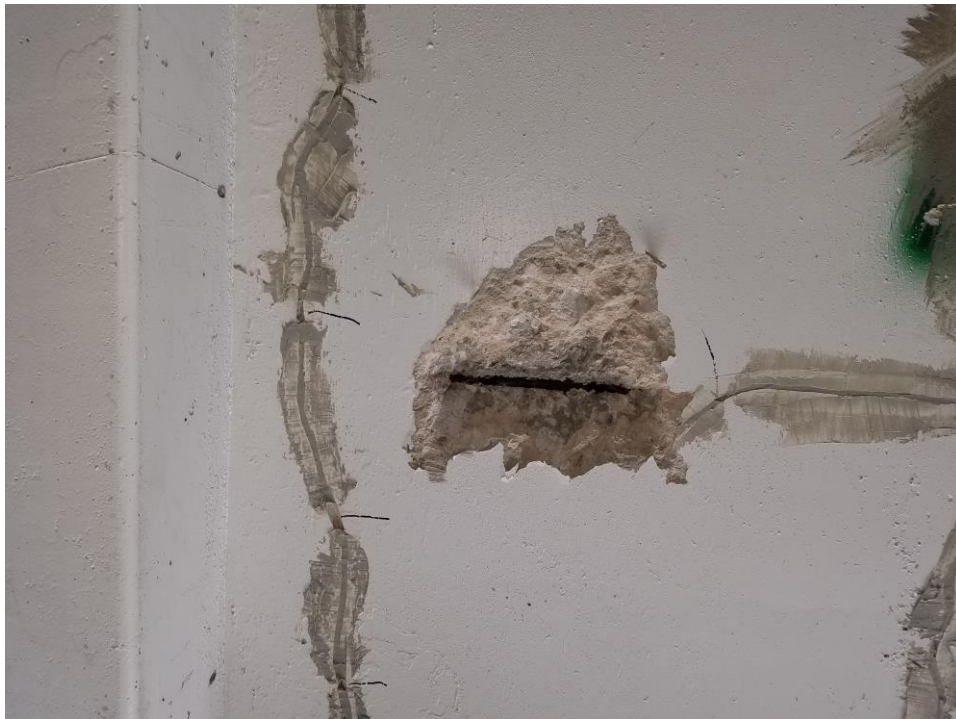
Photo 2: Slab Repair Location where demolition was performed

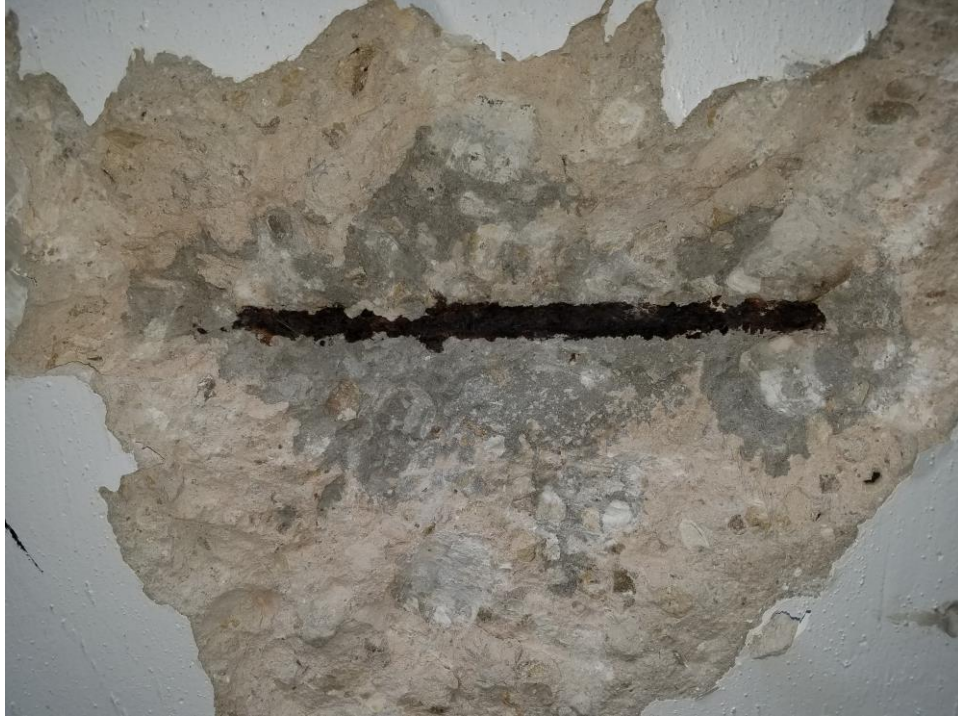
Photo 3: Reinforcement was not cleaned, and corrosion was present

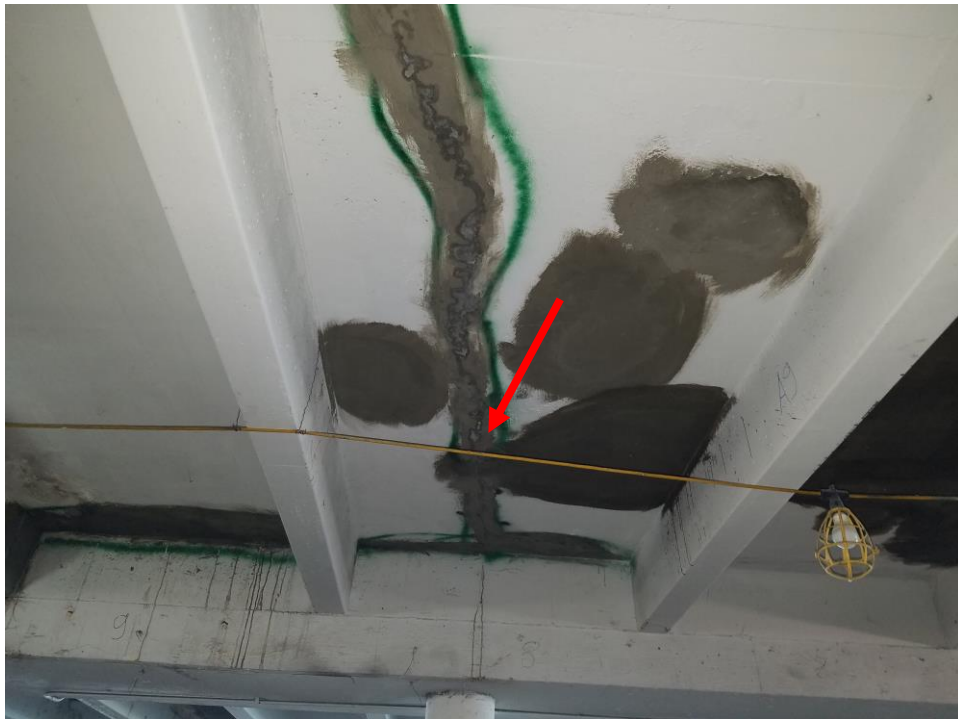
some fashion as evidenced by the observation of repair mortar along the crack (see Photo No. 4)
Based on the visual observations, it seems apparent that the exposed reinforcement inside the overhead slab was minimally corroded at the time of our investigation & inspection, exhibiting an oxidized steel layer that appears to be limited to minor surface corrosion. It also seems apparent that the crack in the concrete slab was not repaired with epoxy based on the observations at the time of our investigation. There was evidence observed, throughout the parking garage, of water penetrating through the slab cracks into the garage, after the crack repairs were performed.

Photo 4: Slab Repair Location where demolition was performed

For this repair and for other slab crack repairs we would require repairs using epoxy injection, typically. It thus seems apparent that this repair was not performed in accordance with generally accepted standards &/or applicable Codes & Standards.

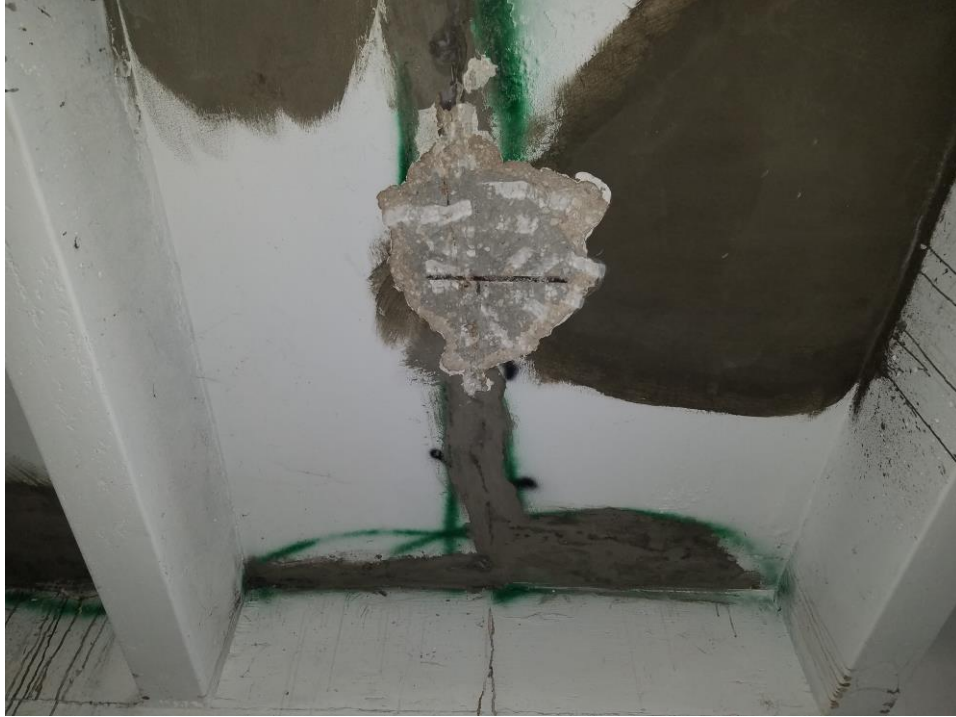
Photo 5: Minor corrosion was observed at the reinforcement

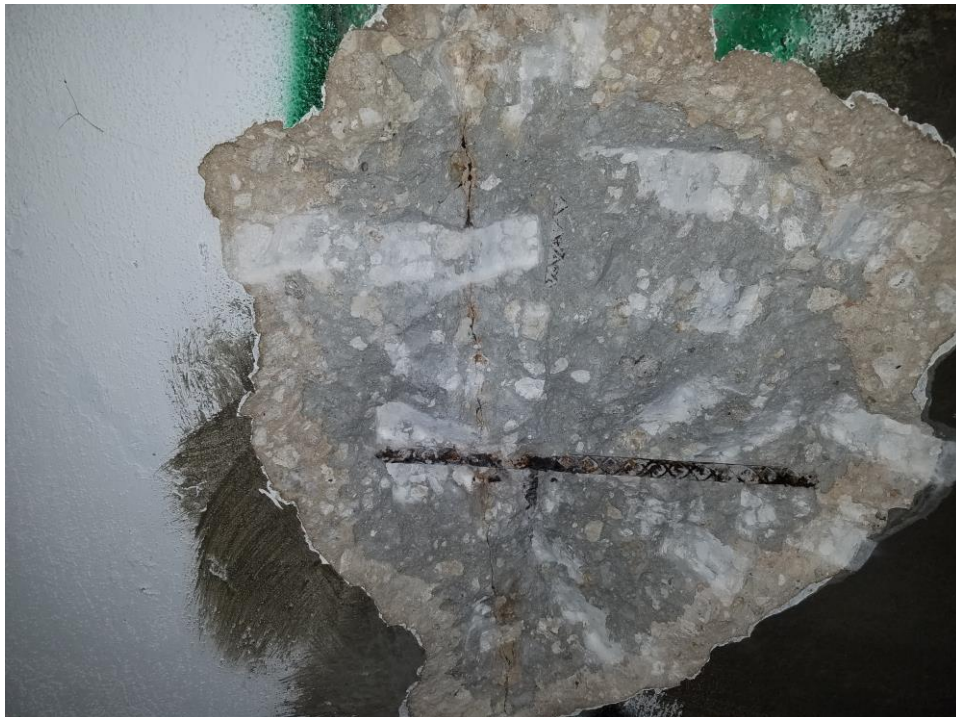
Photo 6: Epoxy was not present at the Crack in overhead slab

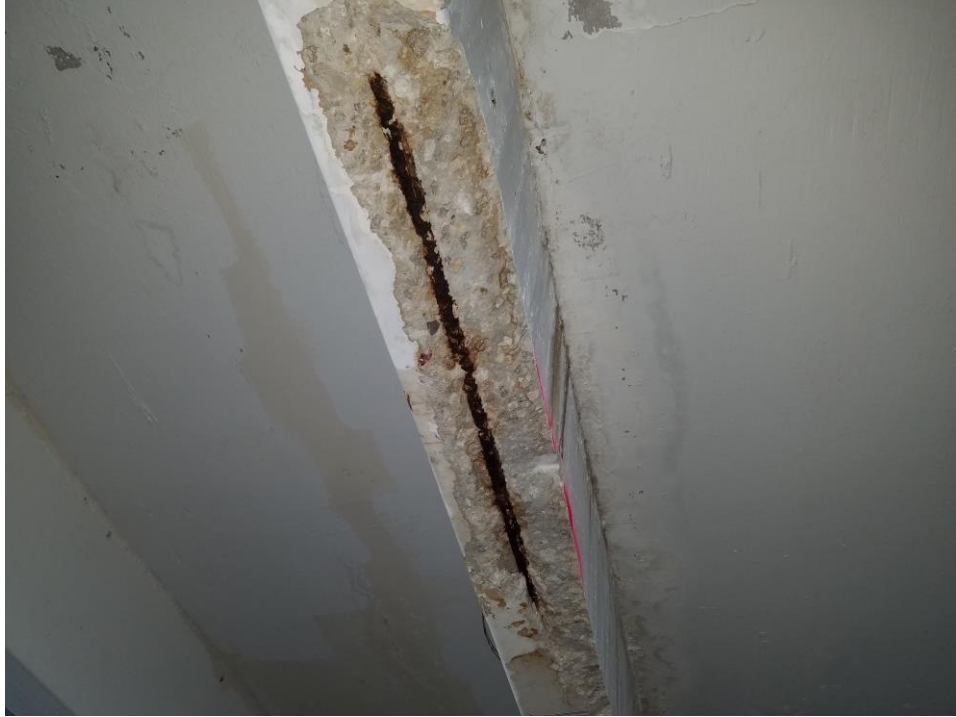
Based on the visual observations, it seems apparent that the exposed reinforcement inside the concrete joist was corroded at the time of our investigation & inspection, with a thick oxidized steel layer and loss of steel cross-section. It also seems apparent that the corroded steel continues further into the concrete member than the area that was opened up during our investigation.

The damaged joist observed at this location ***was not repaired*** during the previous concrete repair project. The reinforced concrete joist is in need of repair in conformance with generally accepted industry standards and applicable Codes for the evaluation of deteriorated reinforced concrete.

Photo 7: No concrete repairs were performed at the joint

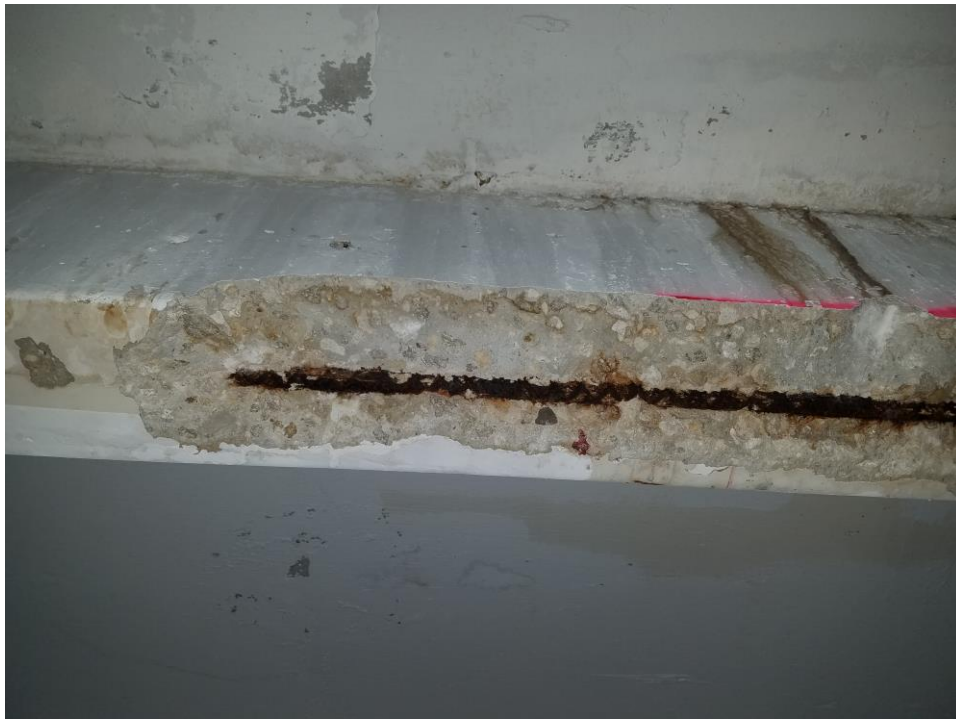
Photo 8: Joist Reinforcement was severely corroded

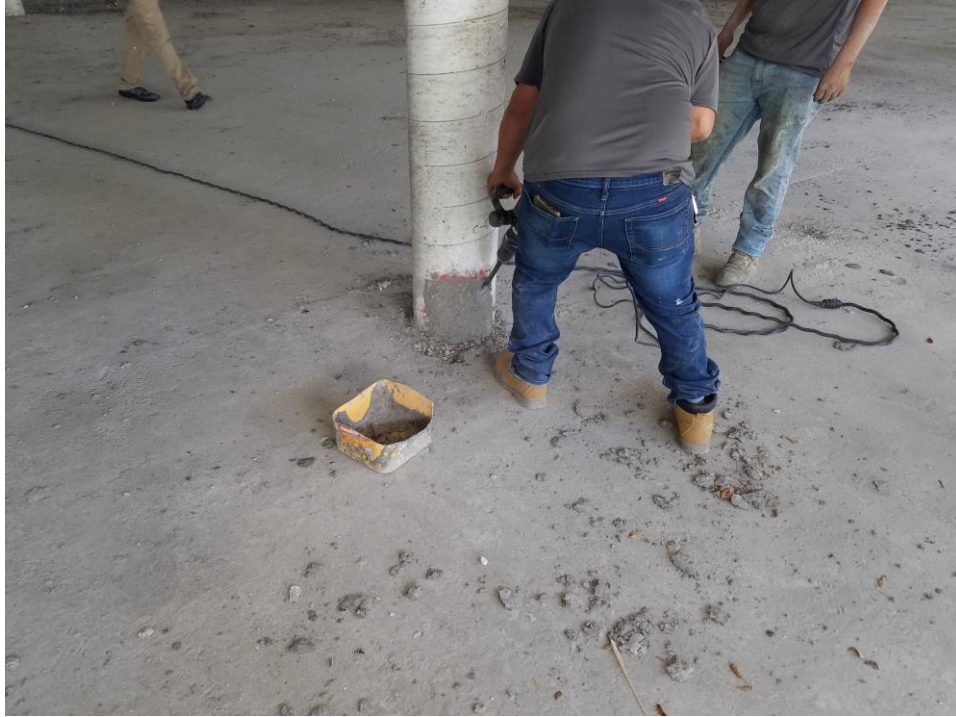
Based on the visual observations, it seems apparent that the exposed reinforcement inside the column was corroded at the time of our investigation & inspection, with an oxidized steel layer that appears to be the un-cleaned, untreated, corroded steel that caused the cracking &/or spalling at this damage site (refer to the “Cause of Reinforced Concrete Deterioration” section above). It also seems apparent that the corroded steel continues further into the concrete member than the area that was opened up during demolition for this repair.

Photo 9: Demolition being performed at the newly repaired column base location

For this repair, we would in part require 1) “chasing” of the steel corrosion at the demolition site requiring opening a further area of the concrete member than was here demolished during the repair, 2) mechanical removal of the oxidized steel by-product down to clean steel, 3) doweling additional steel if required for cross-section steel strength, 4) surface preparation of the corroded steel and the application of an approved bonding agent / primer / rust inhibitor to the steel, 5) use of an approved special-purpose repair concrete containing inhibitor(s) and specified, controlled, moisture content. It thus seems apparent that this repair was not performed in accordance with generally accepted standards &/or applicable Codes & Standards (refer to the “Repair Methods for Deteriorated Reinforced Concrete” section above).

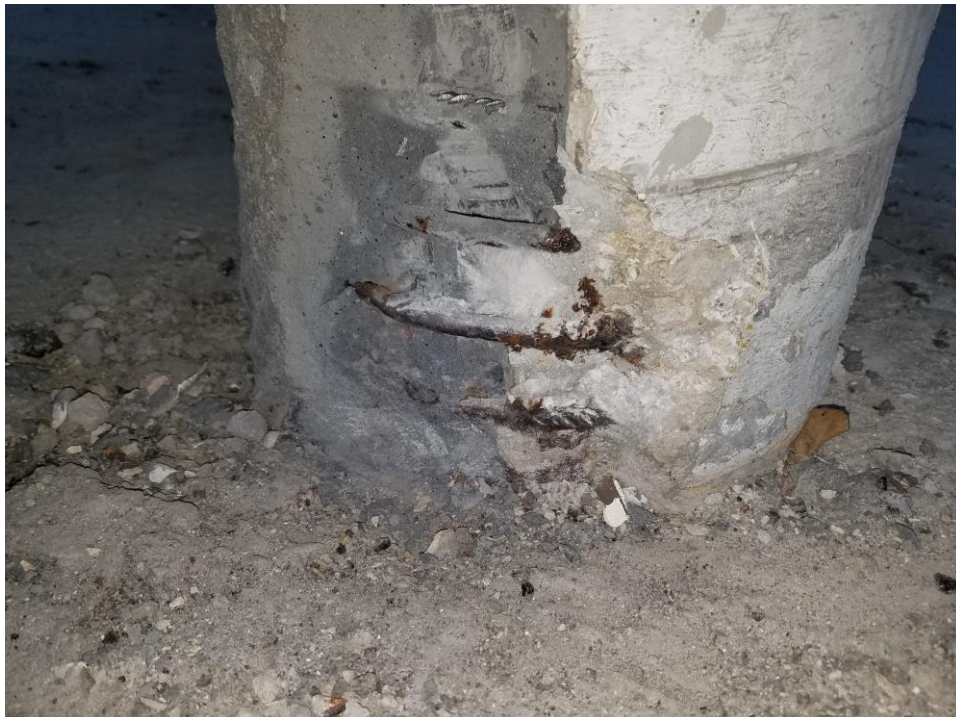
Photo 10: Evidence of corrosion in the column reinforcement

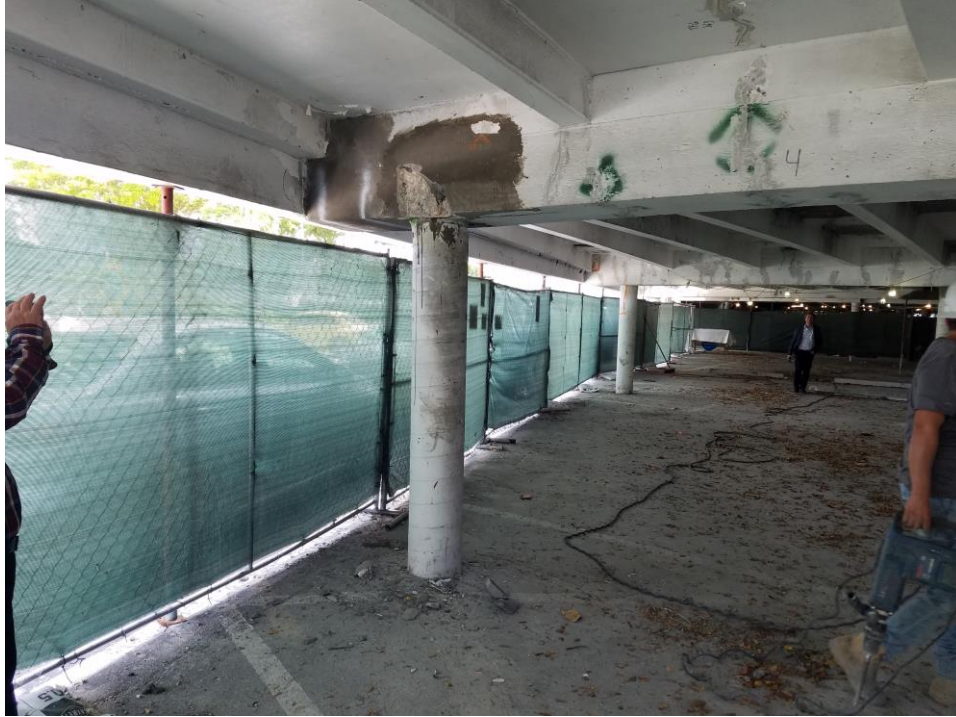
A section of concrete beam was demolished at a previous repair site to expose the repair concrete, the existing (original) concrete surface at the repair site, the interface of the original concrete surface and the repair concrete, and the steel reinforcement inside the beam. Notably, a large chunk of concrete came loose and fell off during demolition.

Based on the visual observations, it seems apparent that the exposed reinforcement inside the beam was corroded at the time of our investigation & inspection, with an oxidized steel layer that appears to be the un-cleaned, untreated, corroded steel that caused the cracking &/or spalling at this damage site (refer to the “Cause of Reinforced Concrete Deterioration” section above). It also seems apparent that the corroded steel continues further into the concrete member than the area that was opened up during demolition for this repair.

Photo 11: Location of newly repaired beam where demolition was performed

For this repair, we would in part require 1) “chasing” of the steel corrosion at the demolition site requiring opening a further area of the concrete member than was here demolished during the repair, 2) mechanical removal of the oxidized steel by-product down to clean steel, 3) doweling additional steel if required for cross-section steel strength, 4) surface preparation of the corroded steel and the application of an approved bonding agent / primer / rust inhibitor to the steel, 5) use of an approved special-purpose repair concrete containing inhibitor(s) and specified, controlled, moisture content. It thus seems apparent that this repair was not performed in accordance with generally accepted standards &/or applicable Codes & Standards (refer to the “Repair Methods for Deteriorated Reinforced Concrete” section above).

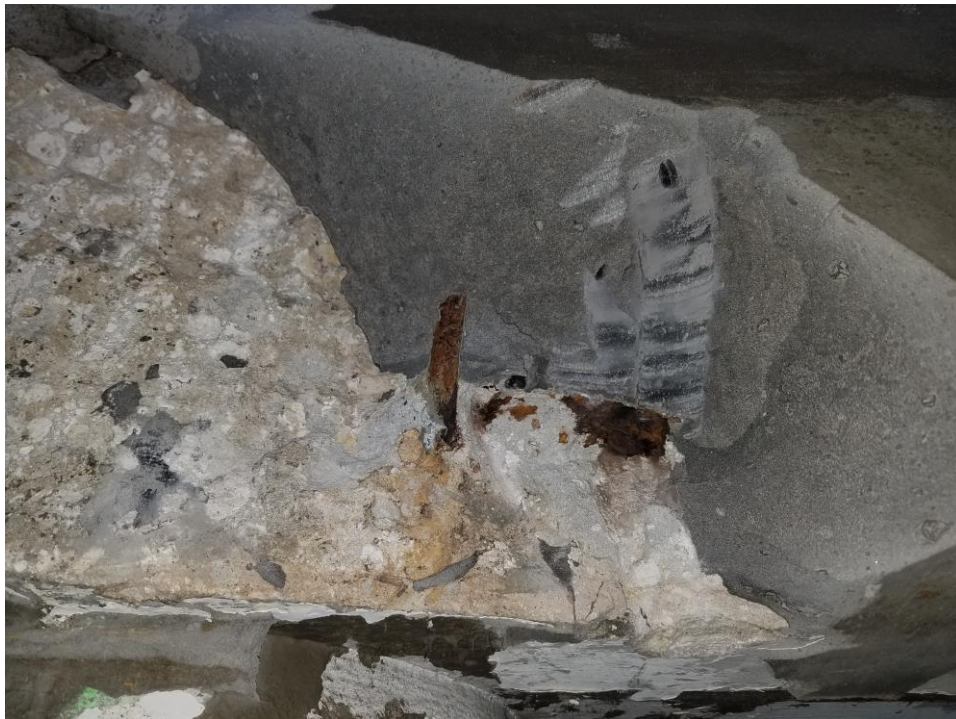
Photo 12: Evidence of corrosion in the reinforcement.

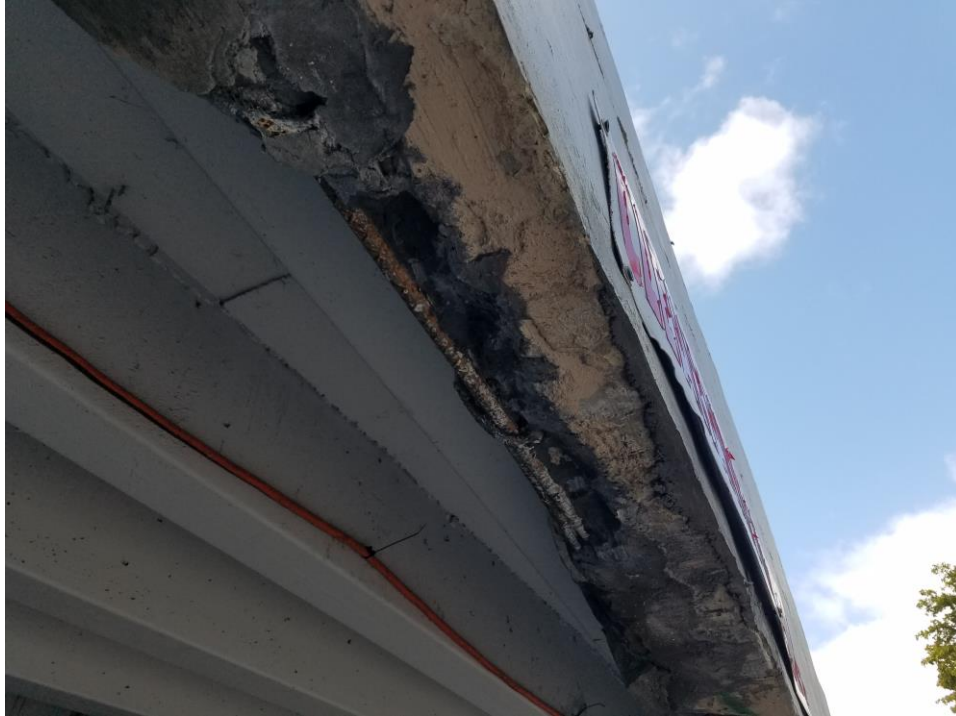
Based on the visual observations, it seems apparent that the exposed reinforcement inside the beam had minor corrosion. The repairs performed to the concrete beam appeared to be sub-standard. It thus seems apparent that this repair was not performed in accordance with generally accepted standards &/or applicable Codes & Standards (refer to the “Repair Methods for Deteriorated Reinforced Concrete” section above).

Photo 15: Sub-standard concrete repair. Evidence of minor corrosion in the reinforcement

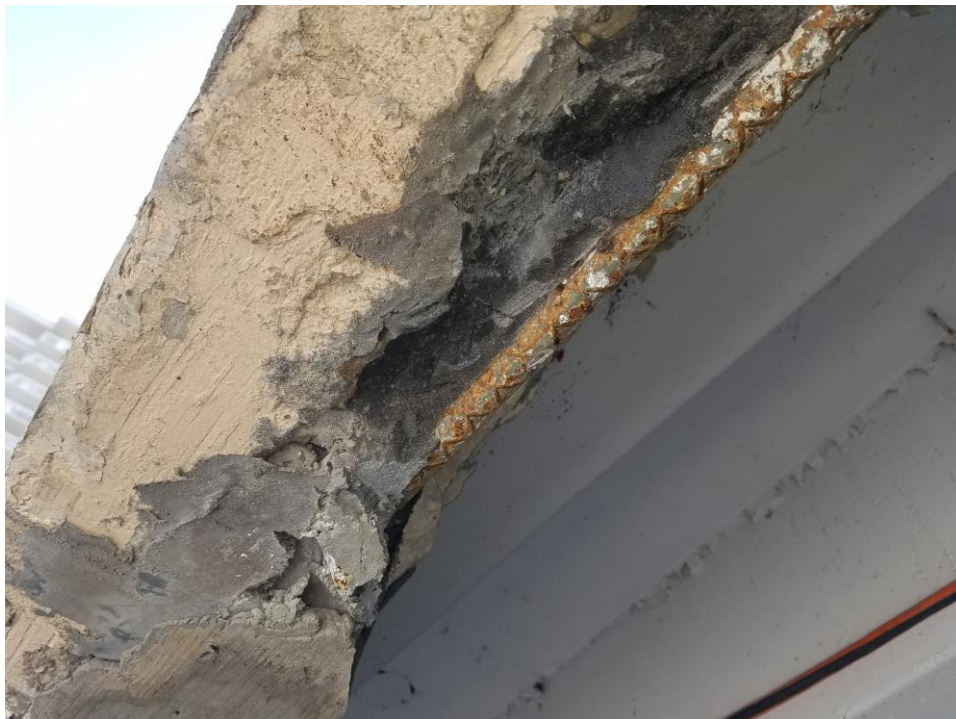
Photo 16: Evidence of minor corrosion in the reinforcement and poorly repaired concrete beam

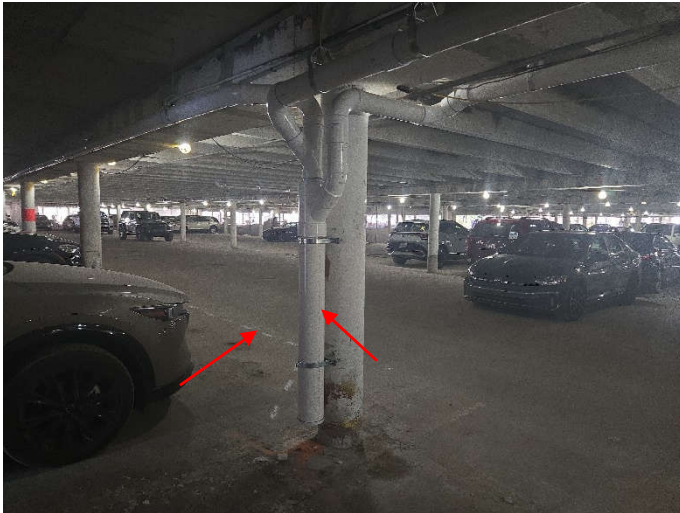
5. Falcon coordinated in the field the routing of the underground connections from the downspouts to the existing main. **(See Photos and Annex A)**
6. Falcon observed that several of the downspouts are missing the cleanouts specified for each of them. **(See Photos)**

Photo # 1. Plaza del Prado, Garage Deck Storm Drainage, Downspout ND1. Proposed underground layout. **The missing clean-out must be installed.**

1. Falcon recommends replacing the existing underground cast iron pipes with Sch 40 PVC pipes, while maintaining the same diameters, locations, and slopes.
2. Falcon recommends installing the missing cleanouts before proceeding with the underground plumbing work and connecting the downspouts.
3. The contractor is responsible for keeping the job site clean and free of construction debris.
4. The contractor is advised to follow industry standards and OSHA guidelines during the installation and testing of the drainage system.

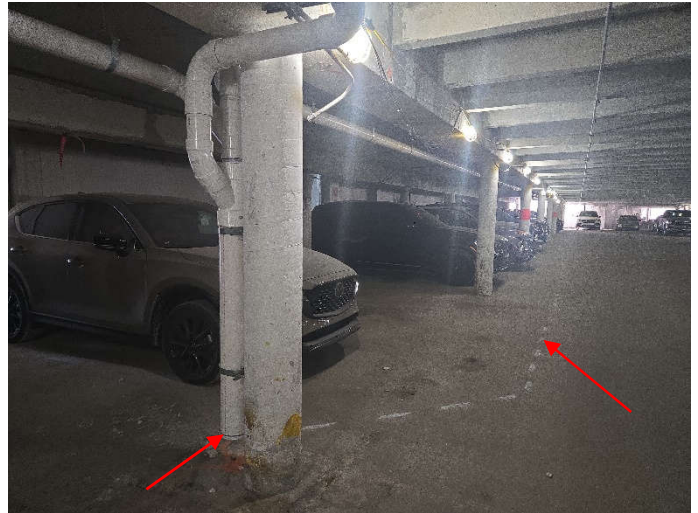
Photo # 2. Plaza del Prado, Garage Deck Storm Drainage, Downspout ND2. Proposed underground layout. **The missing clean-out must be installed.**

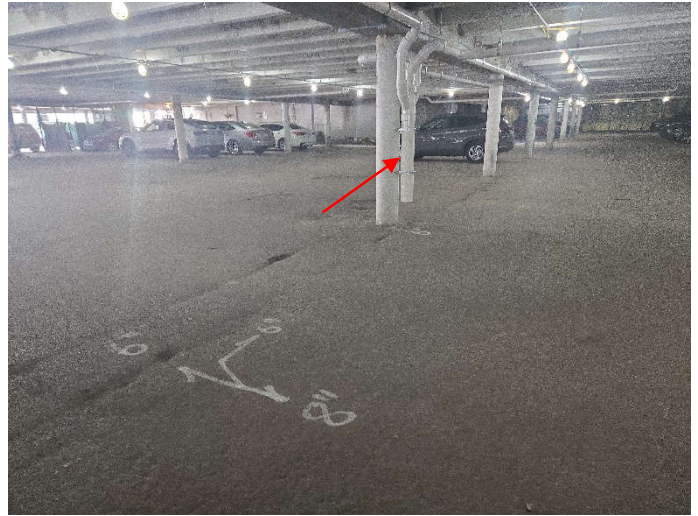
Photo # 6. Plaza del Prado, Garage Deck Storm Drainage, Downspout ND3. Proposed underground layout. ***The missing clean-out must be installed.***

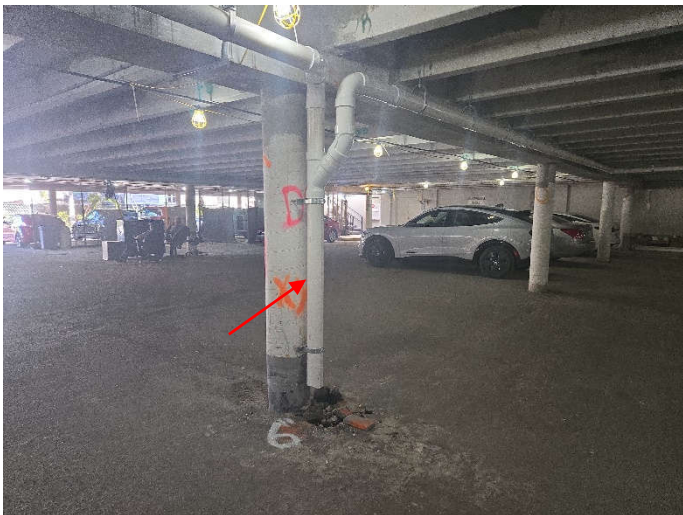
Photo # 7. Plaza del Prado, Garage Deck Storm Drainage, Downspout D9. The diameter must be increased to 6" and the clean-out must be installed.

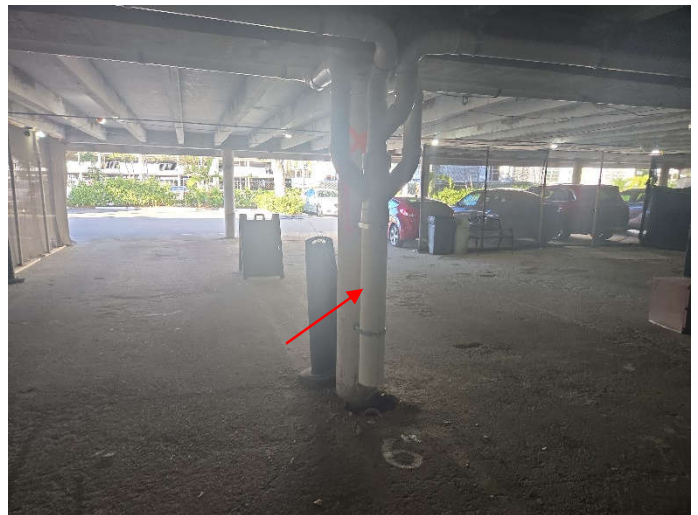
Photo # 8. Plaza del Prado, Garage Deck Storm Drainage, Downspout D8. ***The missing clean-out must be installed.***
