City of Aventura
 Community Development Department
 Building Division
 19200 W Country Club Drive
 Aventura, FL 33180
 305.466.8937 | permits@cityofaventura.com

NOTICE TO THE CITY OF AVENTURA BUILDING DIVISION OF EMPLOYMENT AS SPECIAL INSPECTOR UNDER THE FLORIDA BUILDING CODE

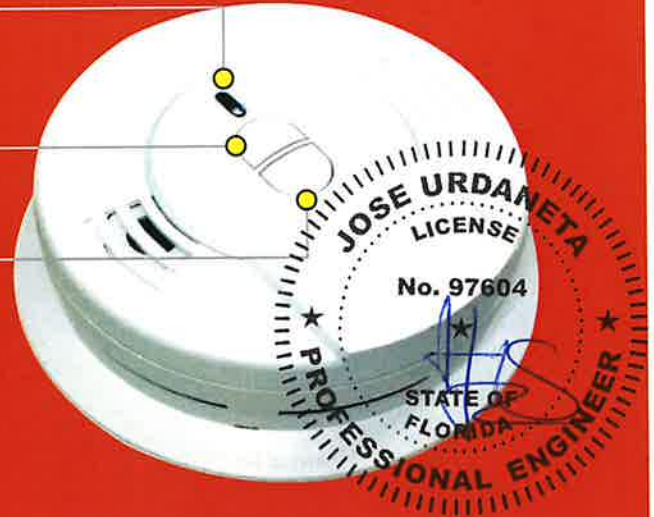
Unit will continue to operate for 10 years

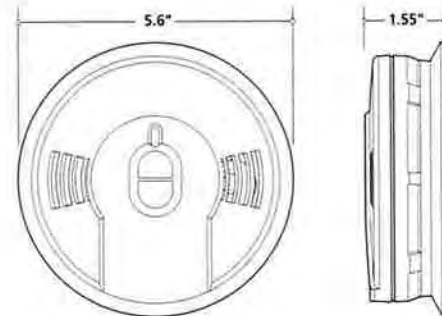
Ordering Information

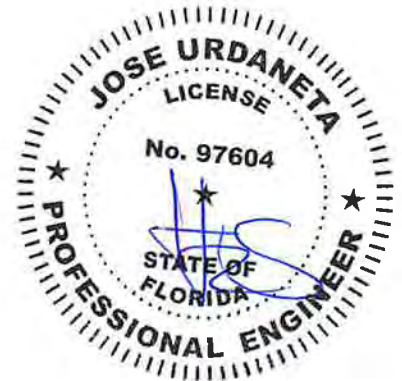
Plaza del Prado Condominium Association

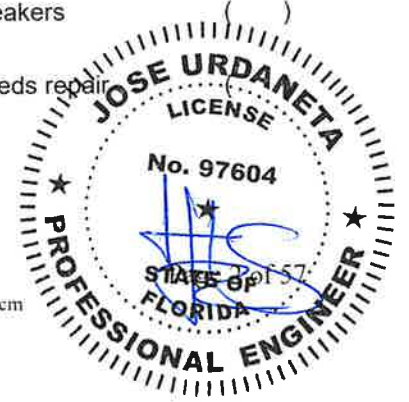
Main Service South Building, Tower IV (For apartment units)

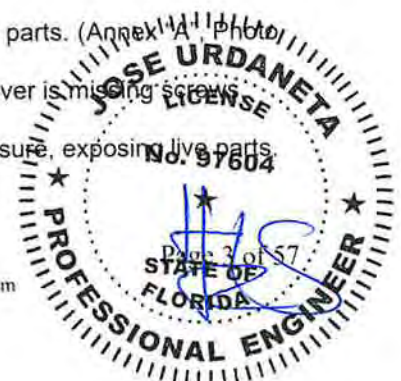
- Meter bank at South building, Tower 4, level 19: missing cover to circuit breaker enclosure, exposing live parts. (Annex "A", Photo # 9)
- Meter bank at South building, tower 3, level 12: missing cover to circuit breaker enclosure, exposing live parts. (Annex "A", Photo # 11)

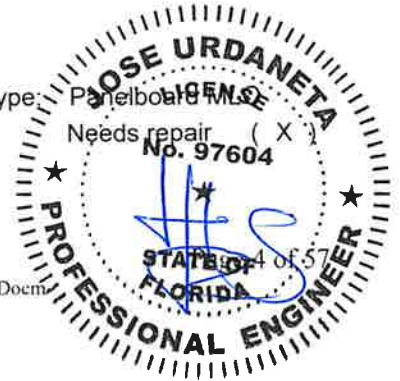
6. Panel #: No label Size: No ratings Phases: 3 Type: Panelboard MLO
Location: East wall – Main electrical room Good () Needs repair (X)
Comments: Panel requires repairs: (Annex "A", Photo # 20).

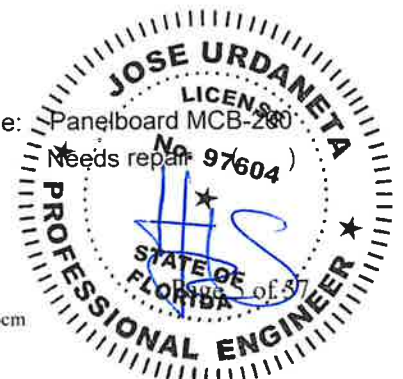
15. Panel#: Sub panel 1	Size: 125 AMPS	Phases: 3	Type: Panelboard MCB-100
Location: Roof CT Mechanical Room	Good	()	Needs repair (X)
Comments: Panel requires repairs: (Annex "A", Photo # 29)

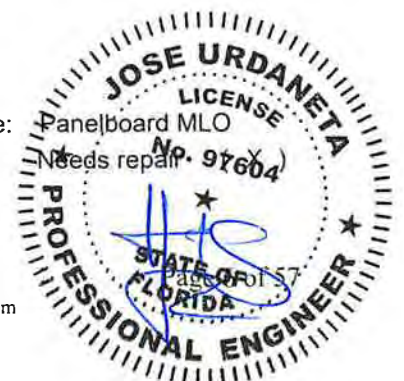
b. Missing circuit directory.

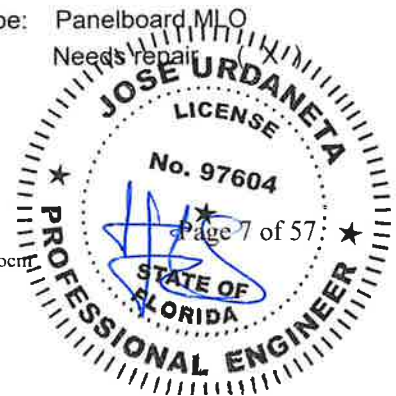
40. Panel#: No label	Size: 200 AMP	Phases: 3	Type: Panelboard MLO
Location: South wall–Main electrical room	Good	()	Needs repair (X)
Comments: Panel requires repairs: (Annex "A", Photo # 55)

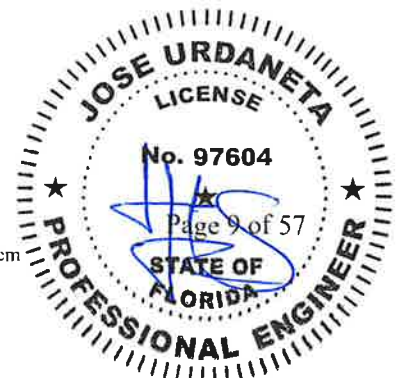
49. Panel#: No label Size: No ratings Phases: 3 Type: Panelboard MLO
Location: Roof CT mechanical room Good () Needs repair (X)
Comments: panel requires repairs. (Annex "A", Photo # 62)

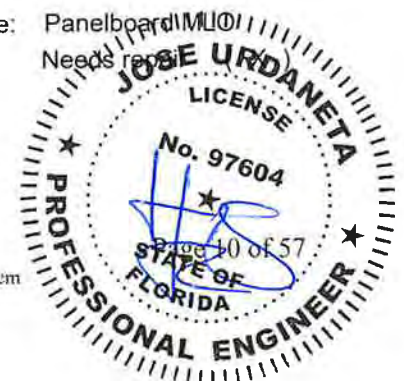
58. Panel#: No label Size: 225 AMP Phases: 3 Type: Panelboard MLO
Location: Tower 4 Laundry room level 14 Good () Needs repair (X)
Comments: Panel requires repairs: (Annex "A", Photo # 72)
a. Missing identification (label).
b. Missing circuit directory.

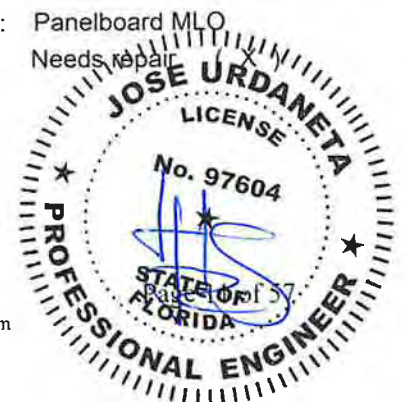
66. Panel#: No label Size: 225 AMP Phases: 3 Type: Panelboard MLO
Location: Tower 3, ground level Good () Needs repair (X)
Comments: Panel requires repairs: (Annex "A", Photo # 83)

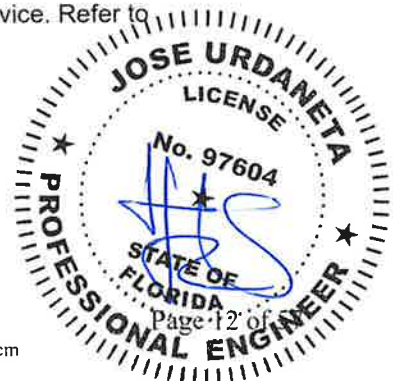
6. GROUNDING SERVICE

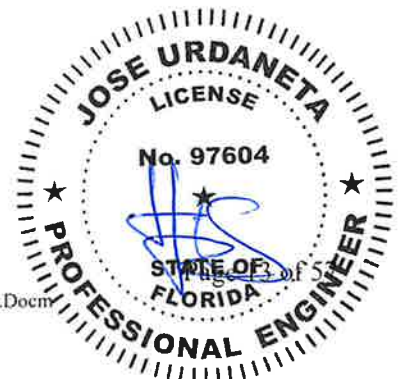
- 3. West 100% OAHU room (Annex "A", Photo # 114)
- 4. East 100% OAHU room (4S) (Annex "A", Photo # 115)
- 5. Main switchgear room, (Annex "A", Photo # 116)

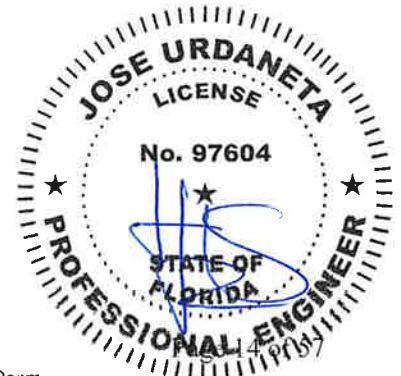
14. FIRE ALARM SYSTEM

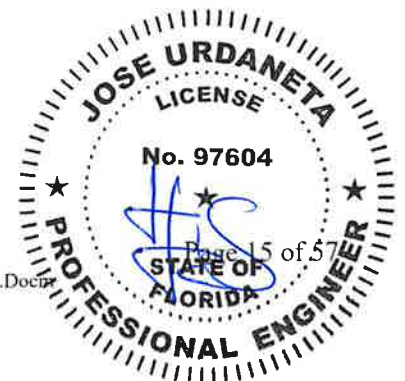
20. SWIMMING POOL WIRING

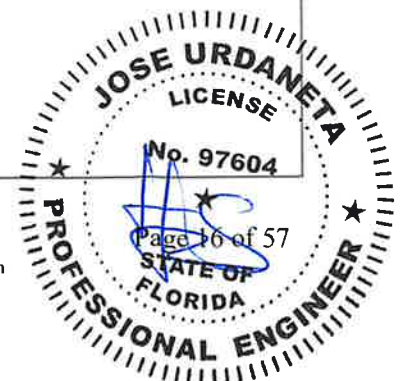
No	Description	Found	% Incidence	Units potentially affected
1	Missing GFCI protection for receptacles in the kitchen	26	81%	555
2	Missing GFCI protection for receptacles in the bathrooms	28	88%	597
3	Missing GFCI protection for receptacles in the balcony	8	25%	171
4	Missing smoke alarm inside the sleeping rooms	30	94%	640
5	Missing smoke alarm outside of the sleeping rooms	5	16%	107
6	Electrical panel: working space clearance violation	14	44%	299
7	Electrical panel: missing proper circuit directory	14	44%	299
8	Electrical panel: opening in circuit spaces	5	16%	107

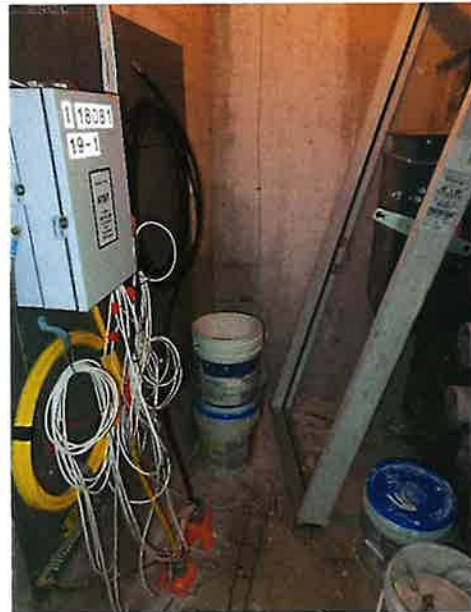
Photo # 4. Meter rooms were found use for storage purposes

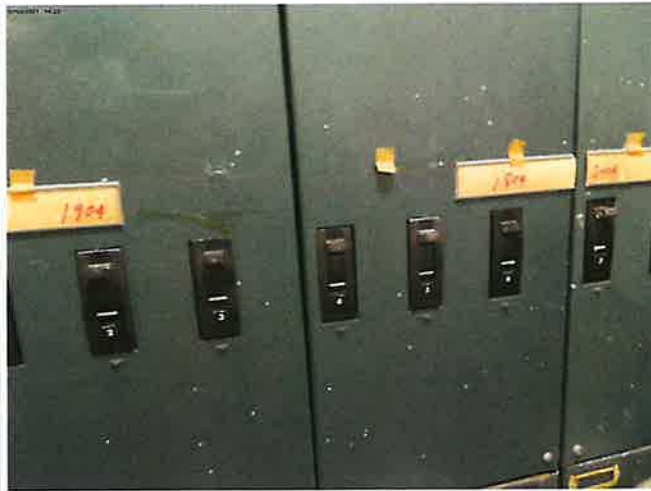
Photo # 5. Some main circuit breakers in the meter cans are missing identification of the unit they serve.

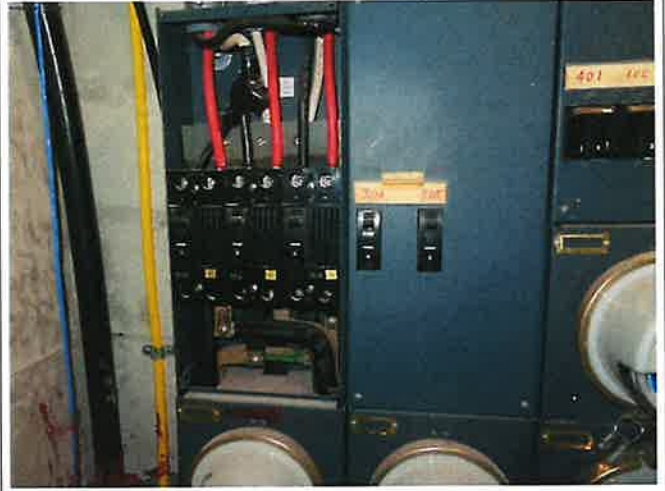
Photo # 6. North building tower 1, meter bank level 3: missing cover for meter can circuit breaker enclosure.

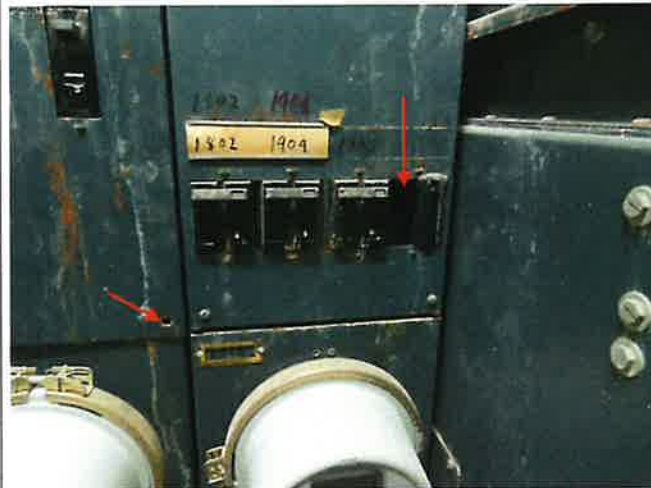
Photo # 7. North building, tower 3, meter room level 19: opening in meter can. Notice the circuit breaker cover is missing screws.

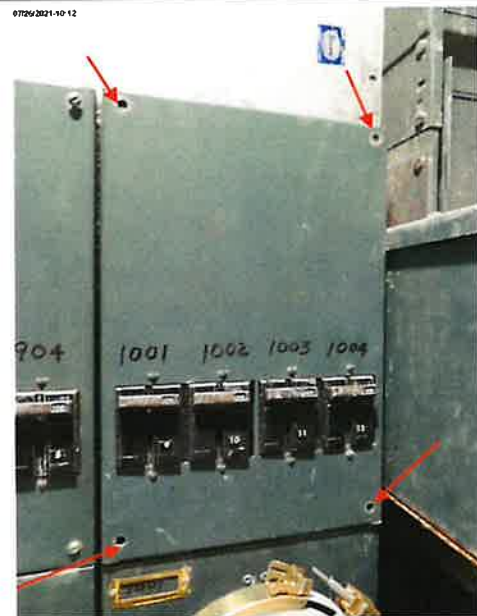
Photo # 8. North building, tower 3, meter room at level 9: circuit-breaker cover missing screws.

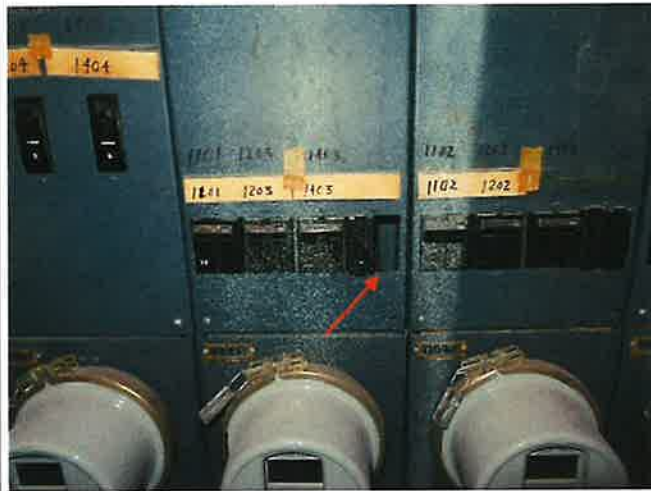
Photo # 9. North building, tower 4, meter room level 12: opening in circuit breaker space.

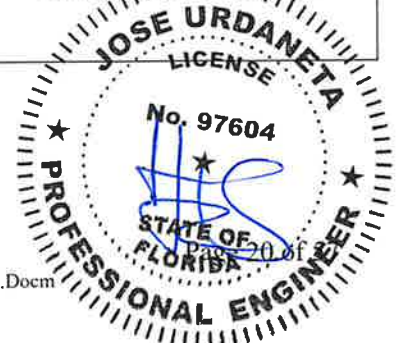
Photo # 12. Gutter in meter room level 3, North building, tower 1.

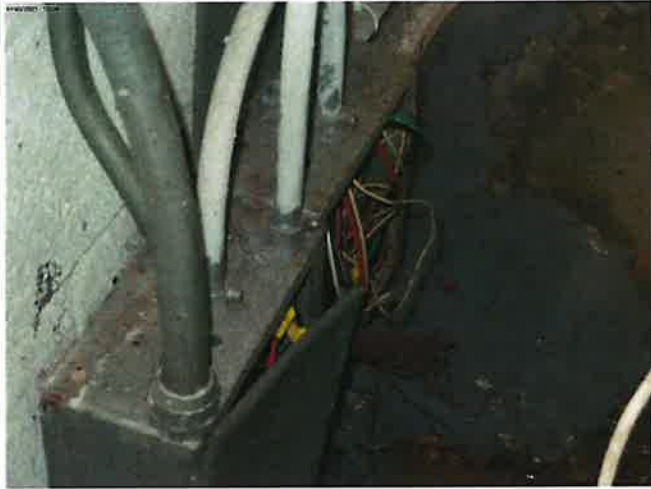
Photo # 13. Outside Air Unit 3N room: gutter missing cover.

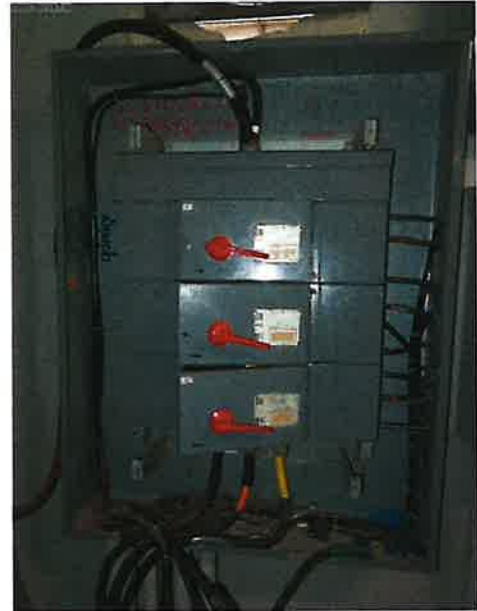
Photo # 14. North building main electrical room electrical panel depicted (item #4.1)

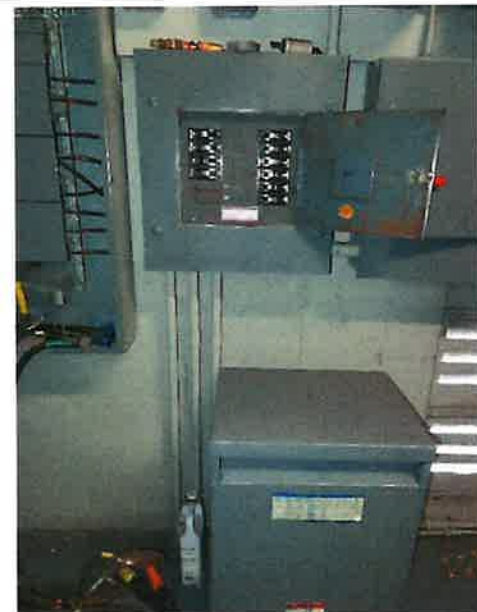
Photo # 16. North building main electrical room electrical panel depicted (item #4.2 "clearance violation")

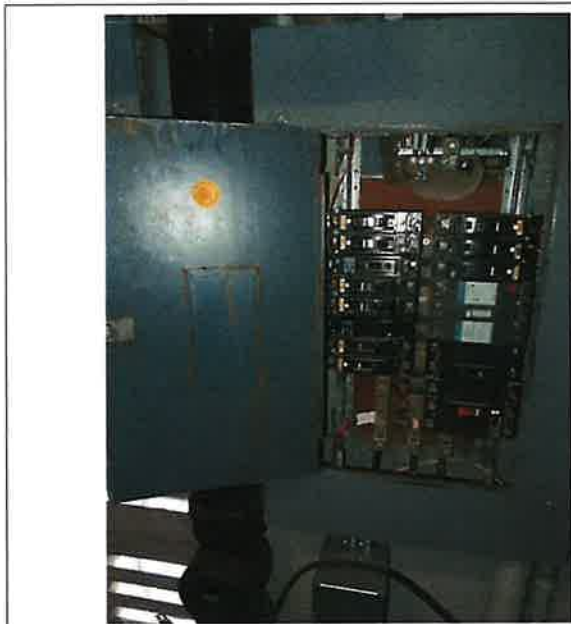
Photo # 17. North building main electrical room electrical panel depicted (item #4.3)

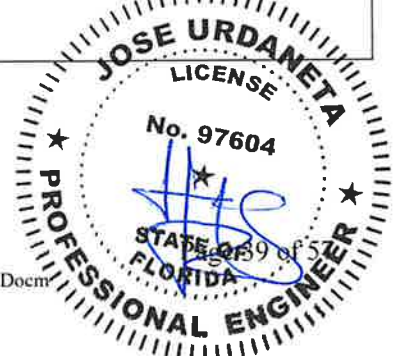
Photo # 88. Marina storage room (under the pool deck) – electrical panel depicted (item #4.70)

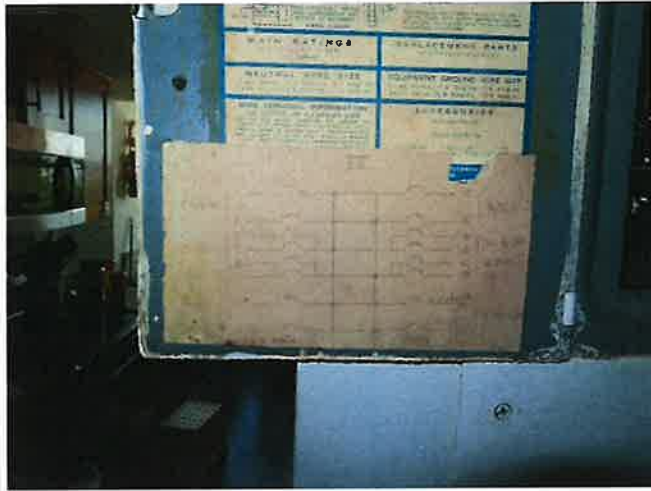
Photo # 89. Typical residential panel where the circuit directory is missing, incomplete or confusing (item #4.71)

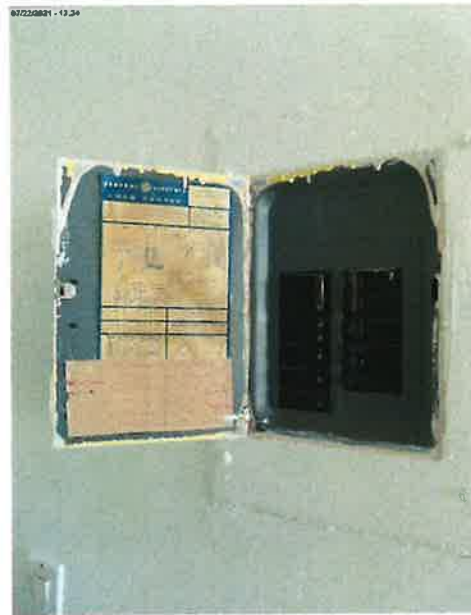
Photo # 90. Typical residential panel where the circuit directory is missing, incomplete or confusing (item #4.71)

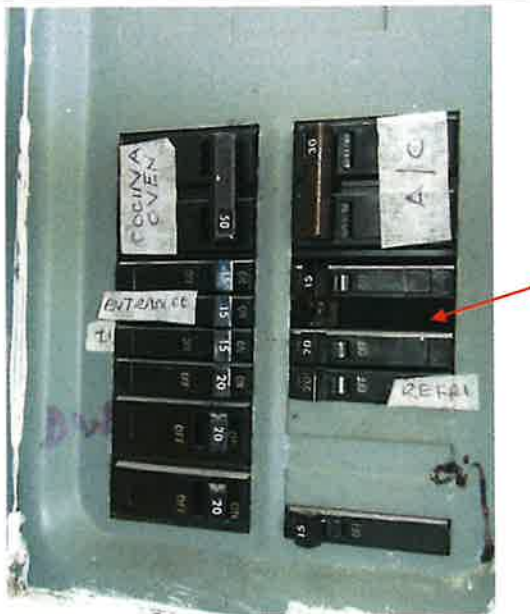
Photo # 91. Typical residential panel having an opening in a circuit space (item #4.71)

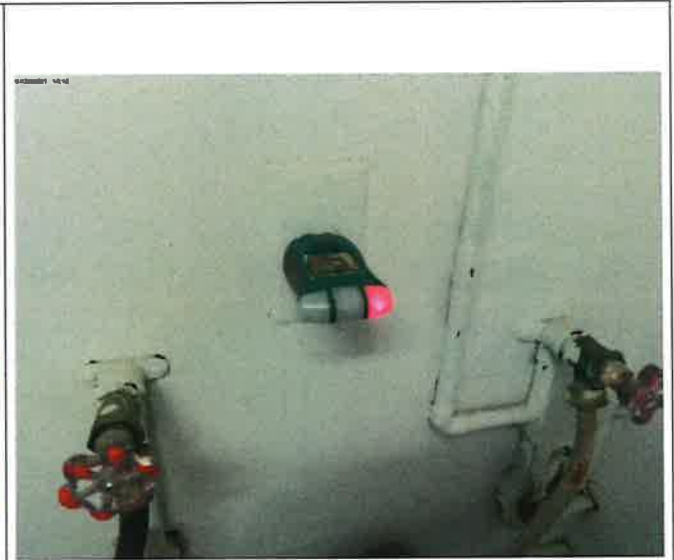
Photo # 96. Laundry room receptacle for the washer machine is depicted. Notice the grounding is missing. Also, GFCI protection is required (typical for all level, all towers in both buildings)

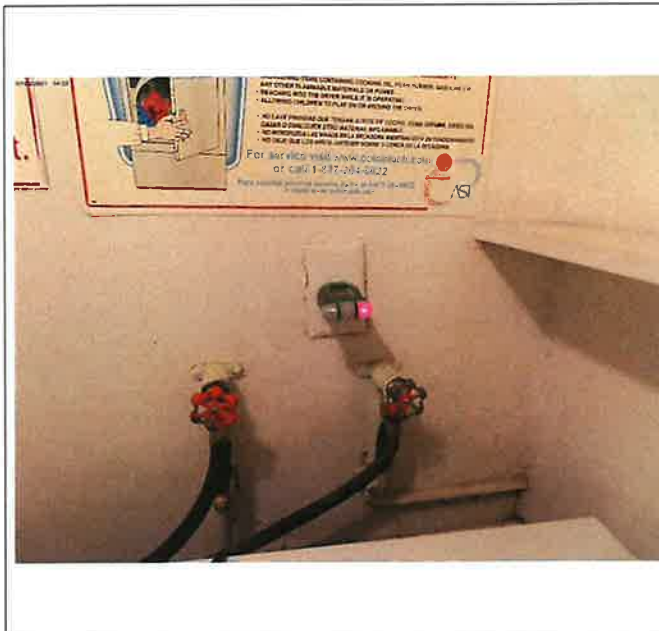
Photo # 97. Laundry room receptacle for the washer machine is depicted. Notice the grounding is missing. Also, GFCI protection is required (typical for all level, all towers in both buildings) (Item #10.b)

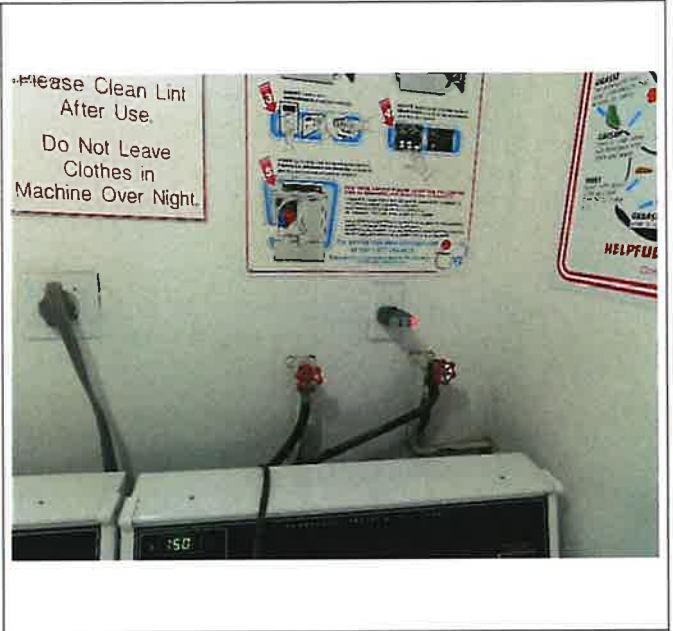
Photo # 98. Laundry room receptacle for the washer machine is depicted. Notice the grounding is missing. Also, GFCI protection is required (typical for all level, all towers in both buildings) (Item #10.b)

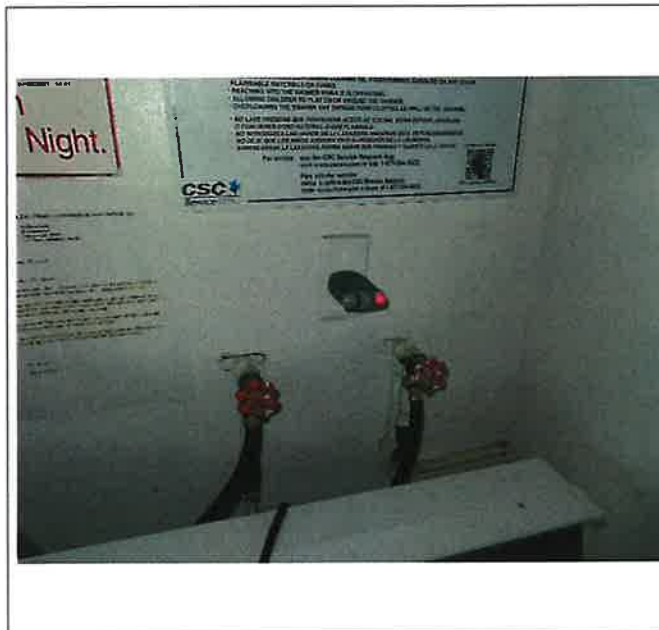
Photo # 99. Laundry room receptacle for the washer machine is depicted. Notice the grounding is missing. Also, GFCI protection is required (typical for all level, all towers in both buildings) (Item #10.b)

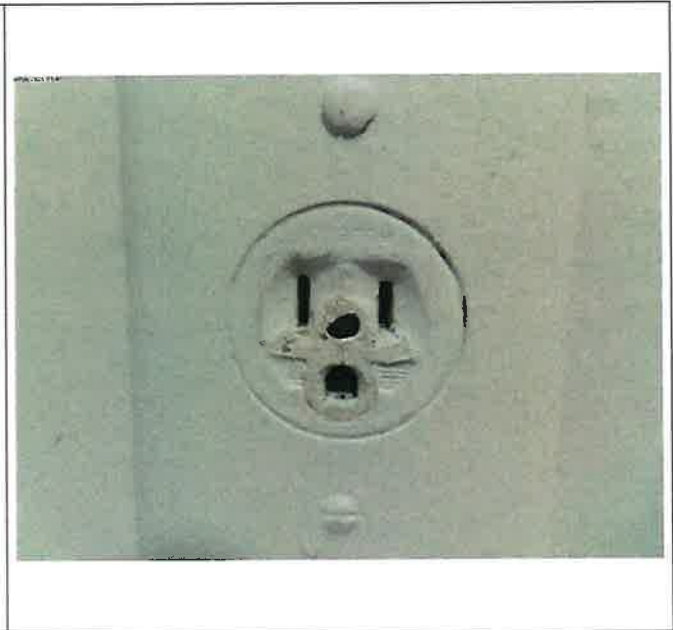
Photo # 100. Laundry room receptacle for the washer machine is depicted. Notice paint has penetrated the connection. Also, GFCI protection is required (Item #10.b)

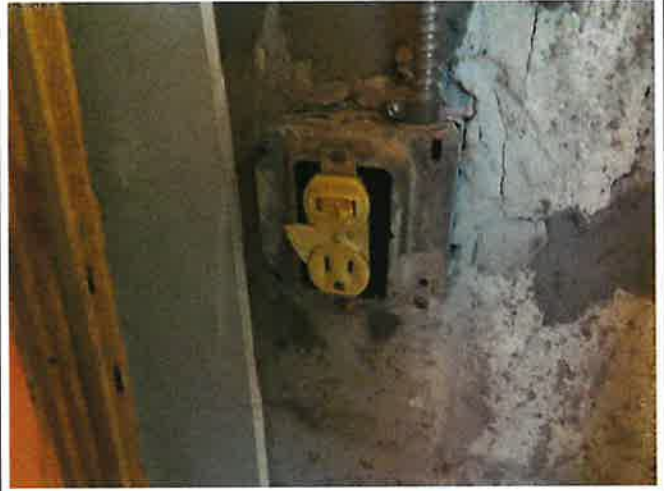
Photo # 102. North building, tower 3, PH level storage room: receptacle missing protective cover.

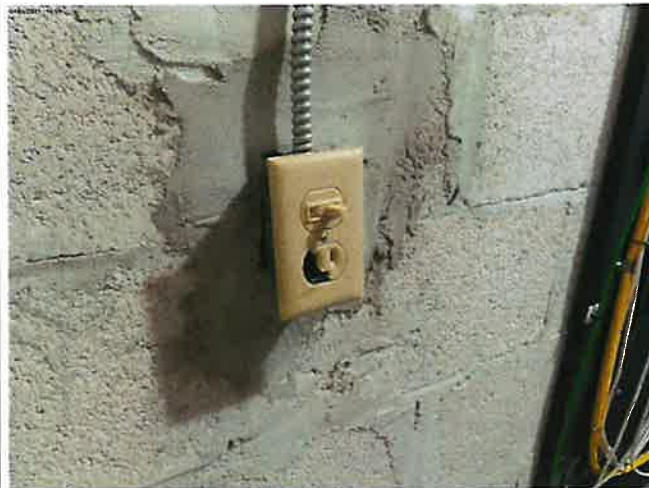
Photo # 103. Broken receptacle cover, meter room level 16, North building, tower 2.

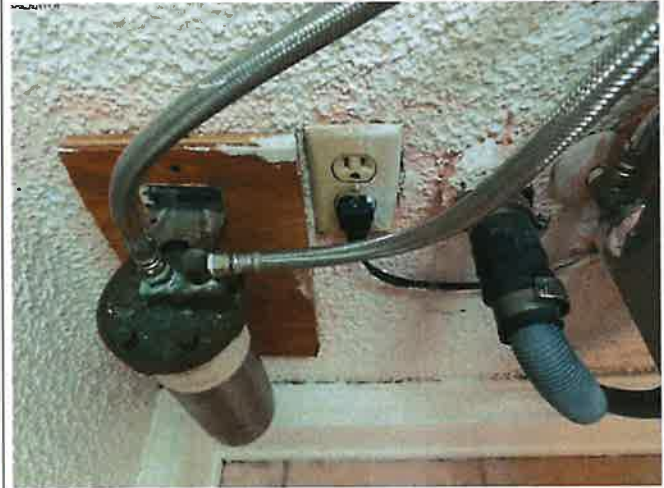
Photo # 104. Receptacle for the drinking water fountain must have GFCI protection.

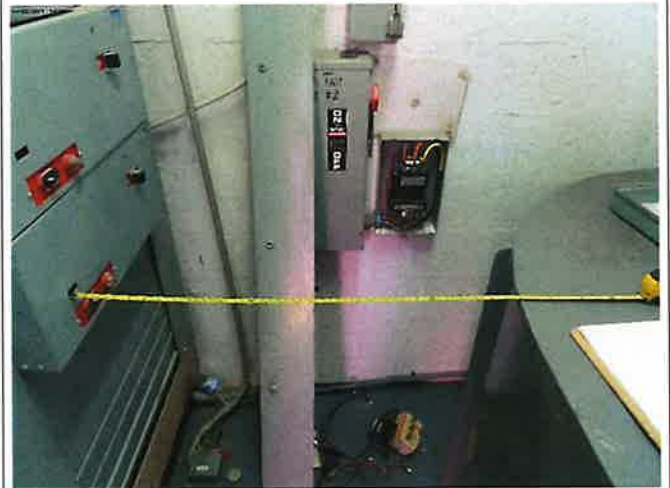
Photo # 124. Working space clearance violation (Item # 10-SOUTH-h)

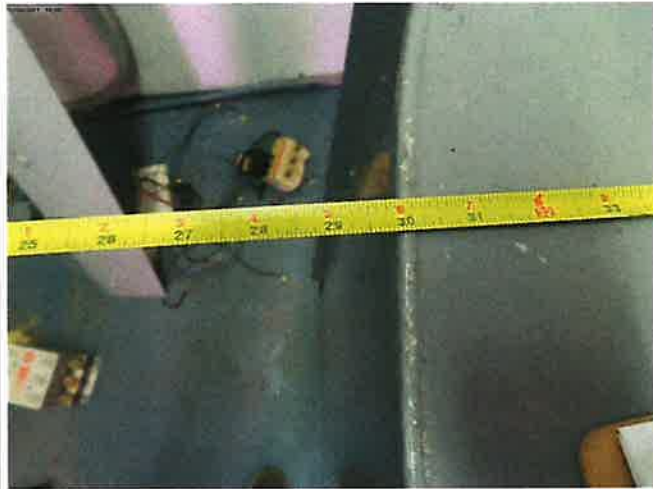
Photo # 125. Working space clearance violation (Item # 10-SOUTH-h)

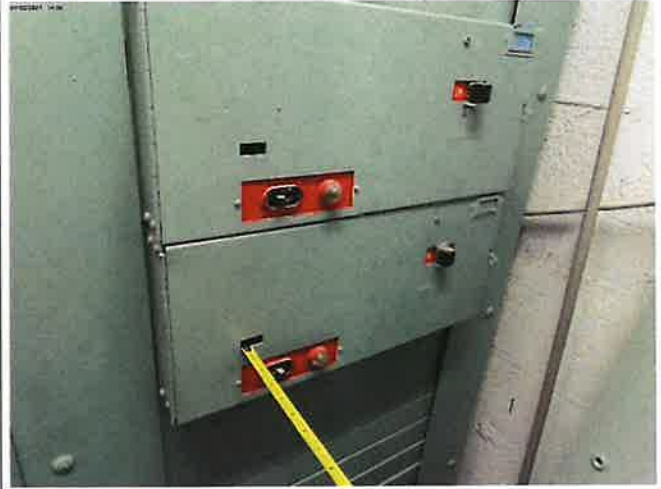
Photo # 126. Working space clearance violation (Item # 10-SOUTH-h)

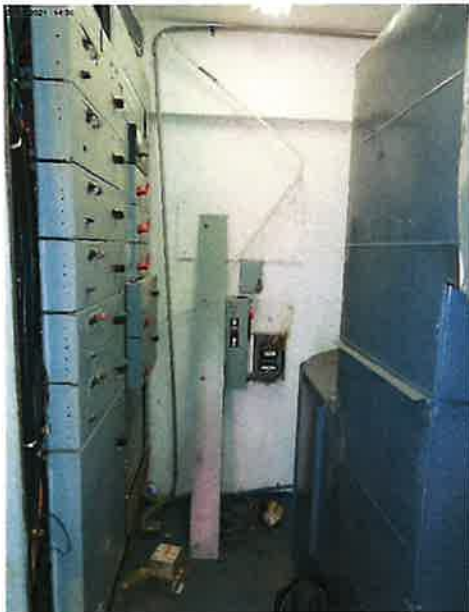
Photo # 127. Working space clearance violation (Item # 10-SOUTH-h)

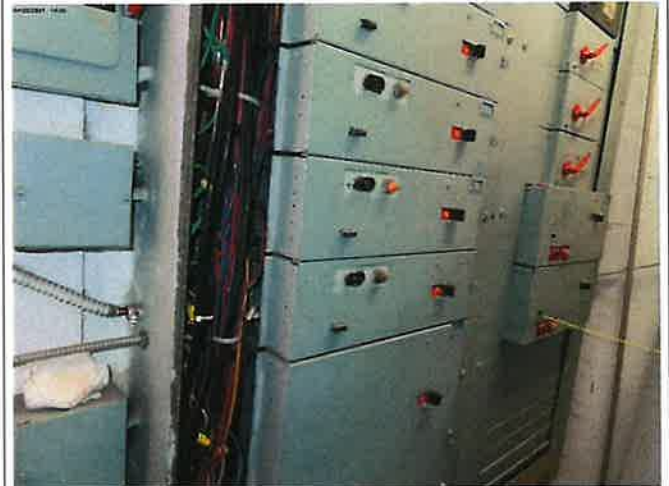
Photo # 128. Missing protective cover for the motor control center (Item # 10-SOUTH-i)

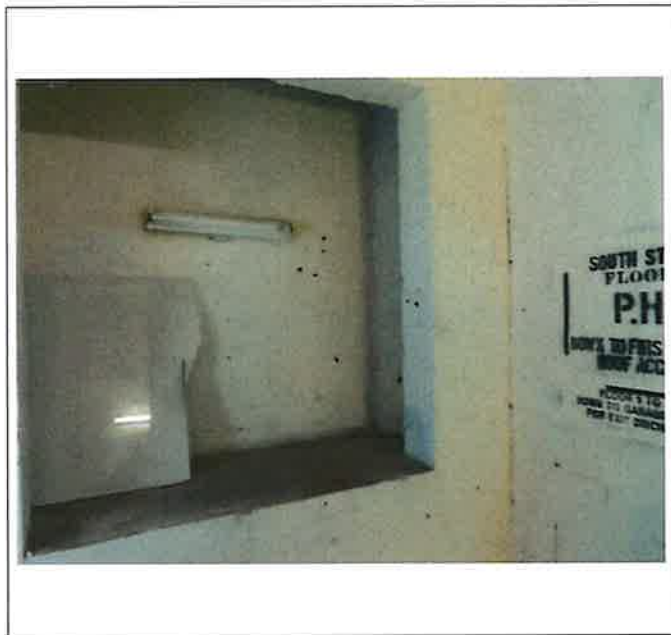
Photo # 129. Insufficient illumination for the building means of egress (Item #13.NORTH-a).

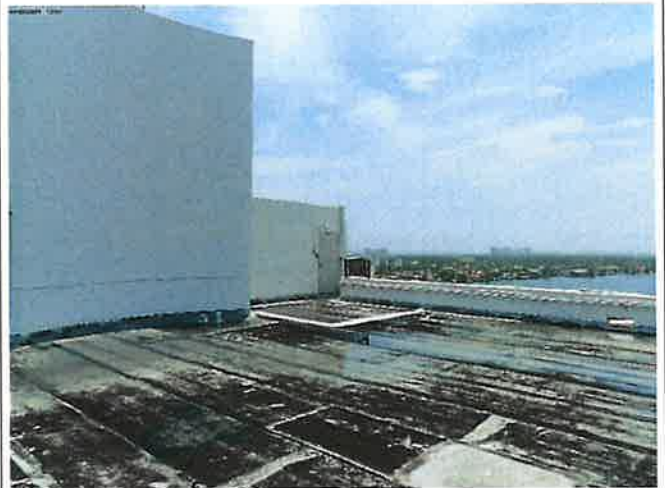
Photo # 140. North building roof: Stairwell exit doors are missing exit sign (Item # 16.a)

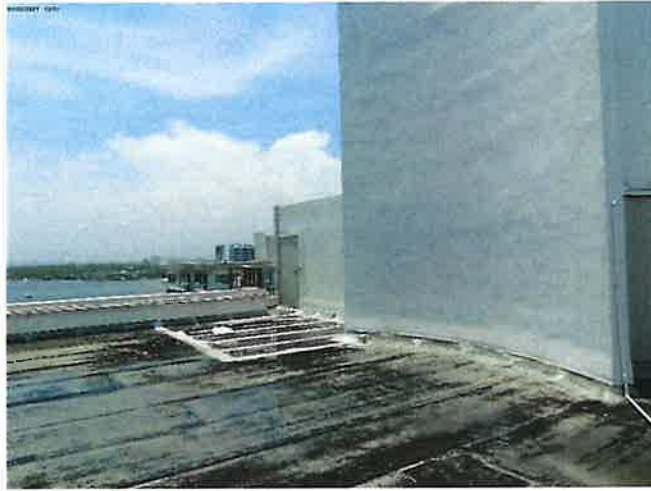
Photo # 141. North building roof: Stairwell exit doors are missing exit sign (Item # 16.a)

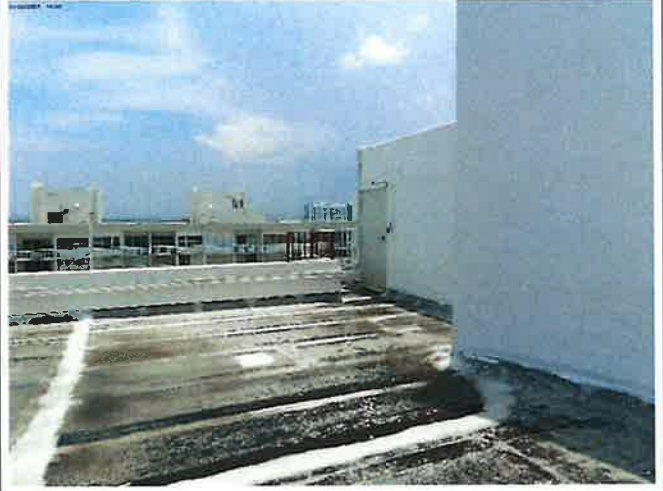
Photo # 142. North building roof: Stairwell exit doors are missing exit sign (Item # 16.a)

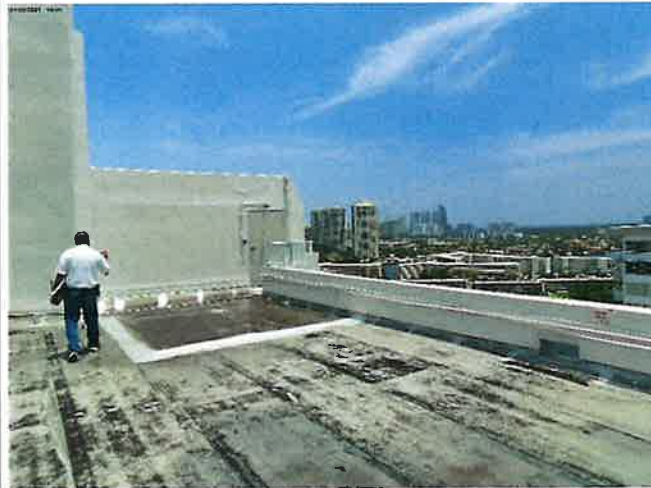
Photo # 143. North building roof: Stairwell exit doors are missing exit sign (Item # 16.a)

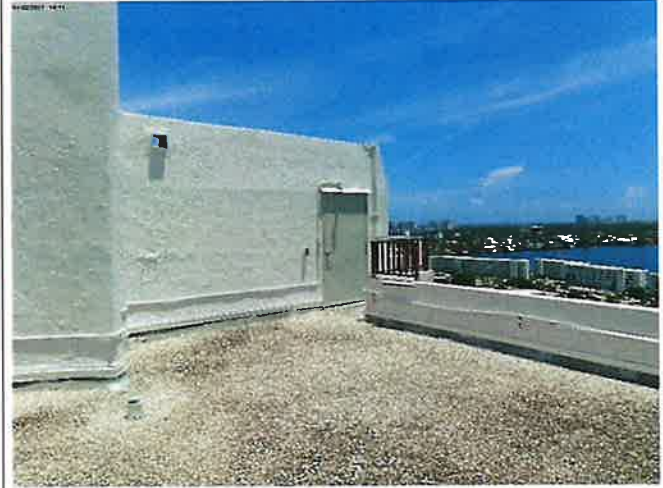
Photo # 144. South building roof: Stairwell exit doors are missing exit sign (Item # 16.b)

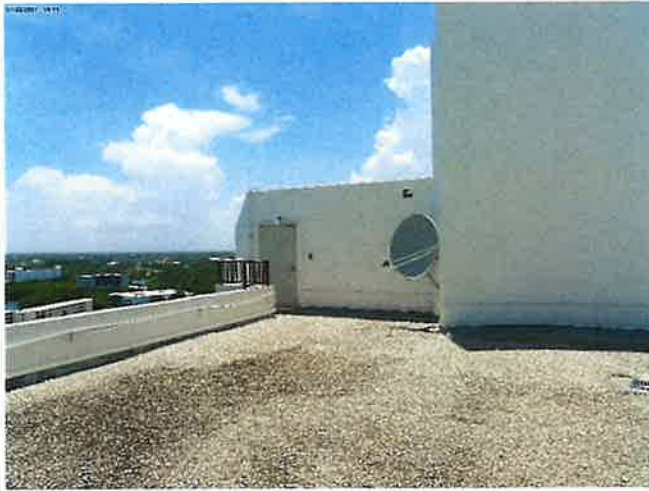
Photo # 145. South building roof: Stairwell exit doors are missing exit sign (Item # 16.b)

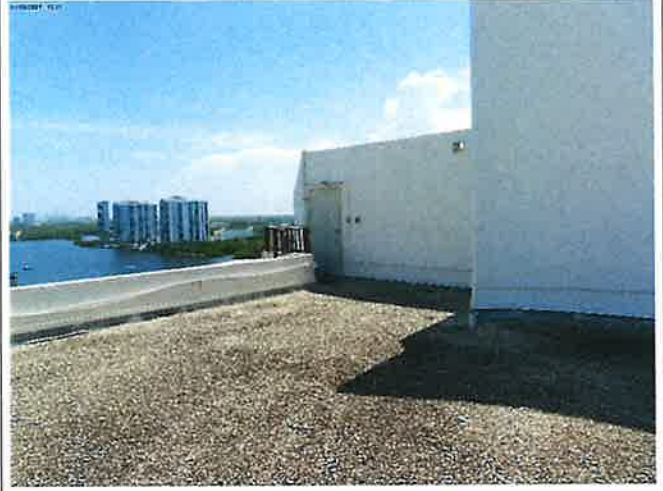
Photo # 146. South building roof: Stairwell exit doors are missing exit sign (Item # 16.b)

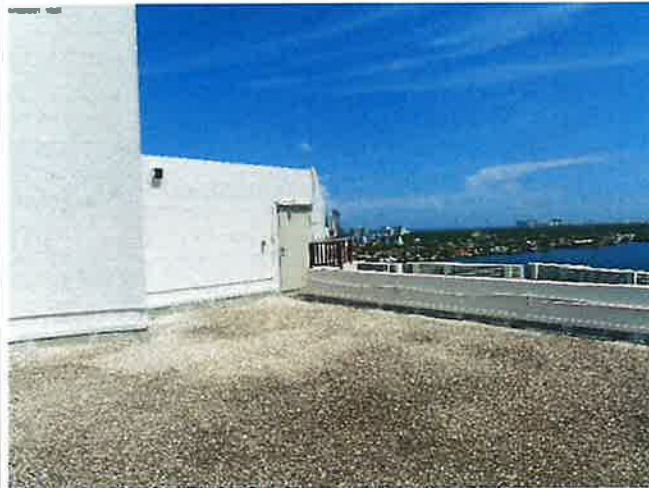
Photo # 147. South building roof: Stairwell exit doors are missing exit sign (Item # 16.b)

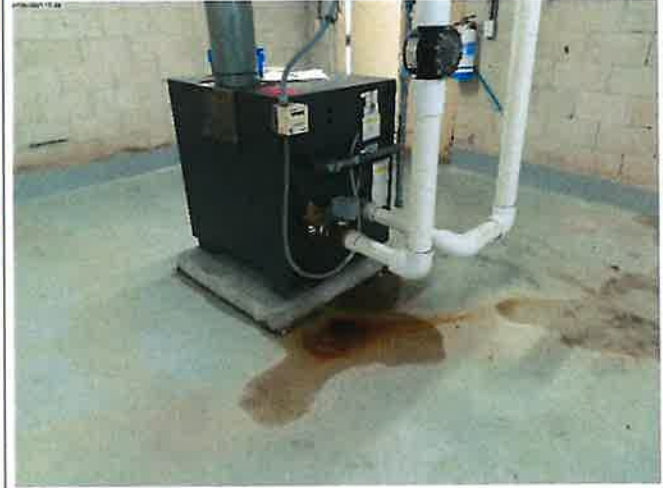
Photo # 148. Pool water heater not bonded. (Item # 20)

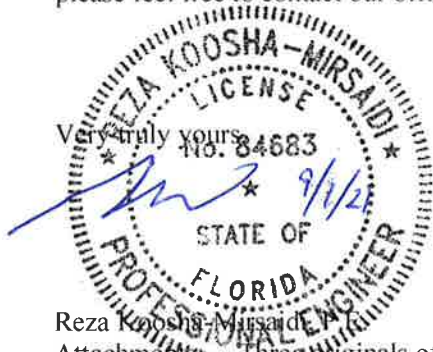
Very truly yours,
Reza Koosha-Mirsaidi
Attachment: Three originals of the Building Safety Inspection Report (Electrical)
Illumination Letter

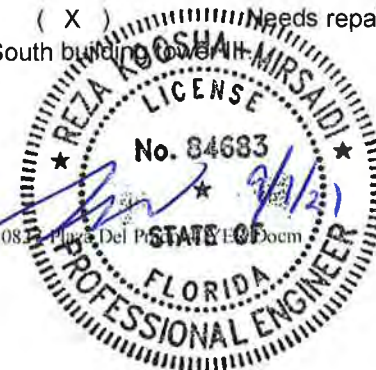
Main Service South Building, Tower IV (For apartment units)

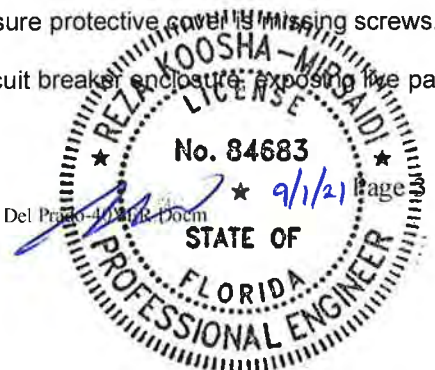
- Meter bank at South building, Tower 4, level 19: missing cover to circuit breaker enclosure, exposing live parts. (Annex "A", Photo # 9)
- Meter bank at South building, tower 3, level 12: missing cover to circuit breaker enclosure, exposing live parts. (Annex "A", Photo # 11)

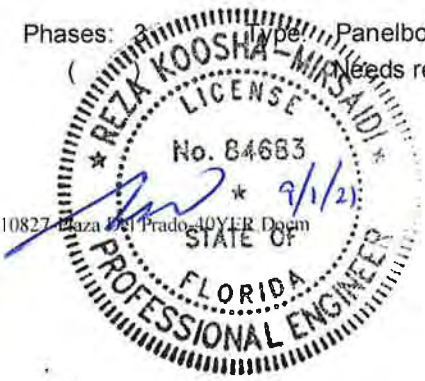
6. Panel #: No label Size: No ratings Phases: 3 Type: Panelboard MLO
Location: East wall – Main electrical room Good () Needs repair (X)
Comments: Panel requires repairs: (Annex "A", Photo # 20).

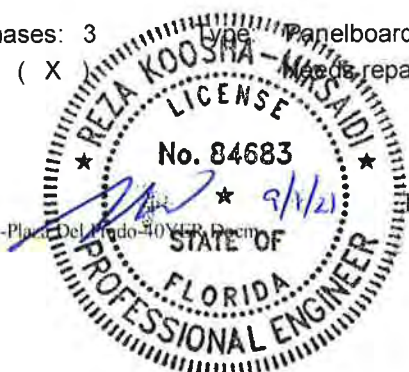
15. Panel#:	Sub panel 1	Size:	125 AMPS	Phases:	3	Type:	Panelboard MCB-100
Location:	Roof CT Mechanical Room		Good	()	Needs repair	(X)
Comments:	Panel requires repairs: (Annex "A", Photo # 29)

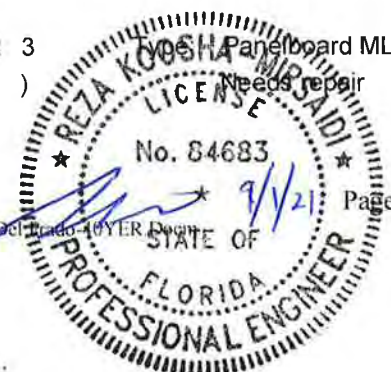
b. Missing circuit directory

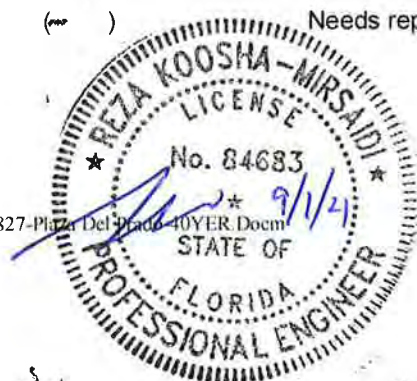
33. Panel#: No label Size: 100 AMPS Phases: 3 Type: Panelboard MLO
Location: Tower 3, ground level ER Good () Needs repair (X)
Comments: Panel requires repairs: (Annex "A", Photo # 47)
a. Missing identification (label).
b. Missing circuit directory
c. Opening in circuit spaces.

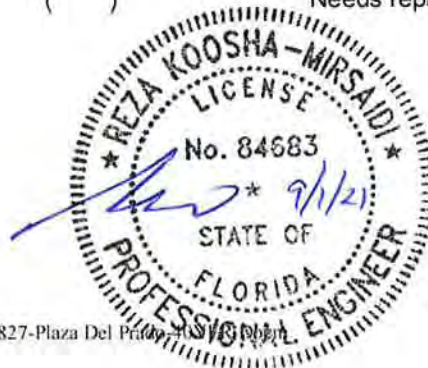
40. Panel#: No label Size: 200 AMP Phases: 3 Type: Panelboard MLO
Location: South wall–Main electrical room Good () Needs repair (X)
Comments: Panel requires repairs: (Annex "A", Photo # 55)
a. Missing identification (label)
a. Missing circuit directory.

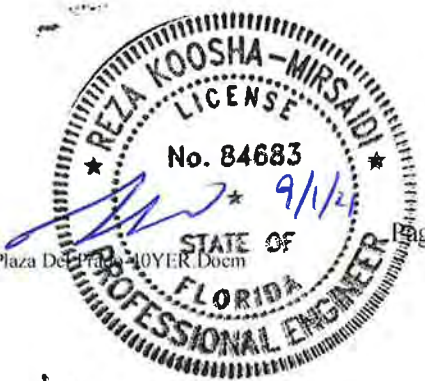
49. Panel#: No label Size: No ratings Phases: 3 Type: Panelboard MLO
Location: Roof CT mechanical room Good () Needs repair (X)
Comments: panel requires repairs. (Annex "A", Photo # 62)
a. Missing identification label.
b. Missing circuit directory.
c. Opening in circuit space.

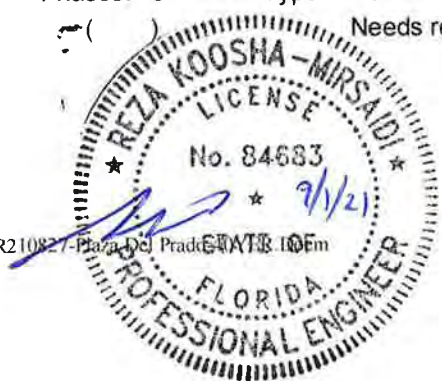
58. Panel#: No label Size: 225 AMP Phases: 3 Type: Panelboard MLO
Location: Tower 4 Laundry room level 14 Good () Needs repair (X)
Comments: Panel requires repairs: (Annex "A", Photo # 72)
a. Missing identification (label).
b. Missing circuit directory.

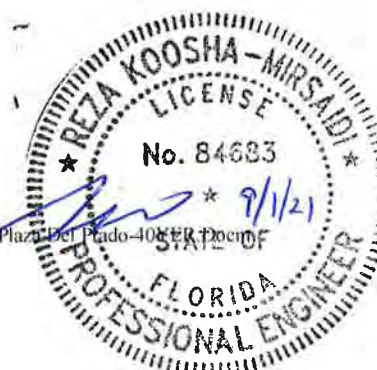
66. Panel#: No label Size: 225 AMP Phases: 3 Type: Panelboard MLO
Location: Tower 3, ground level Good () Needs repair (X)
Comments: Panel requires repairs: (Annex "A", Photo # 83)

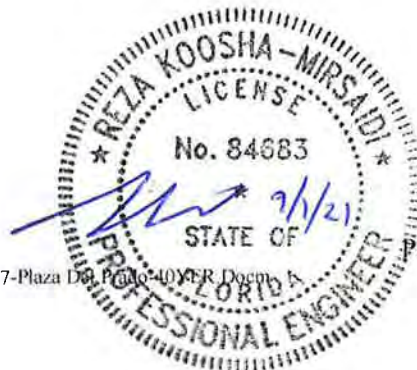
6. GROUNDING SERVICE

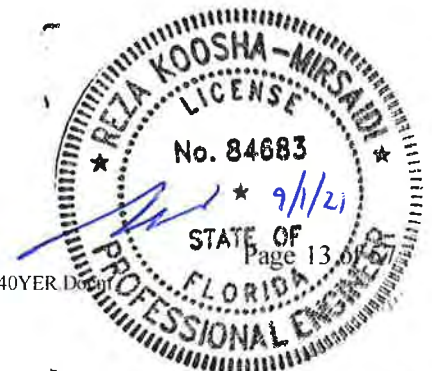
3. West 100% OAHU room (Annex "A", Photo # 114)
 4. East 100% OAHU room (4S) (Annex "A", Photo # 115)
 5. Main switchgear room, (Annex "A", Photo # 116)
 6. Tower 4, ground level (service disconnect switch) (Annex "A", Photo # 117)

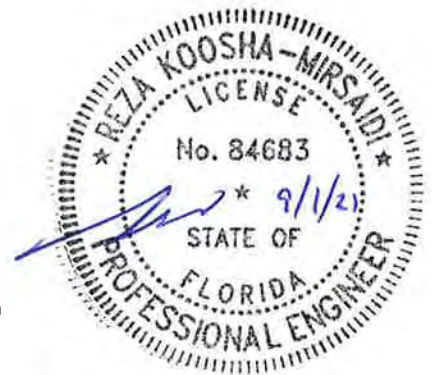
14. FIRE ALARM SYSTEM

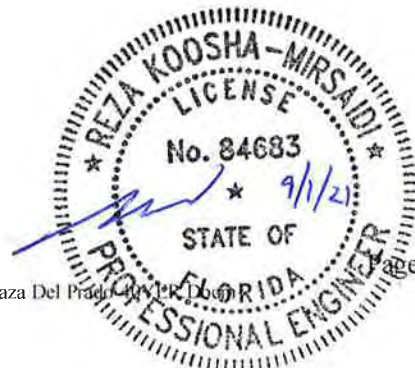
20. SWIMMING POOL WIRING

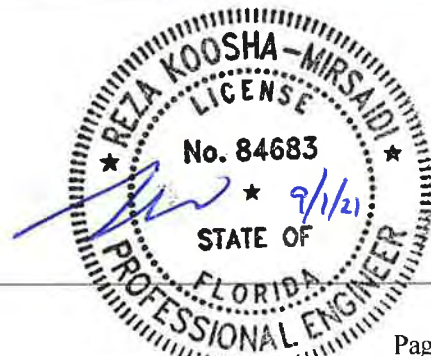
No	Description	Found	% Incidence	Units potentially affected
1	Missing GFCI protection for receptacles in the kitchen	26	81%	555
2	Missing GFCI protection for receptacles in the bathrooms	28	88%	597
3	Missing GFCI protection for receptacles in the balcony	8	25%	171
4	Missing smoke alarm inside the sleeping rooms	30	94%	640
5	Missing smoke alarm outside of the sleeping rooms	5	16%	107
6	Electrical panel: working space clearance violation	14	44%	299
7	Electrical panel: missing proper circuit directory	14	44%	299
8	Electrical panel: opening in circuit spaces	5	16%	107

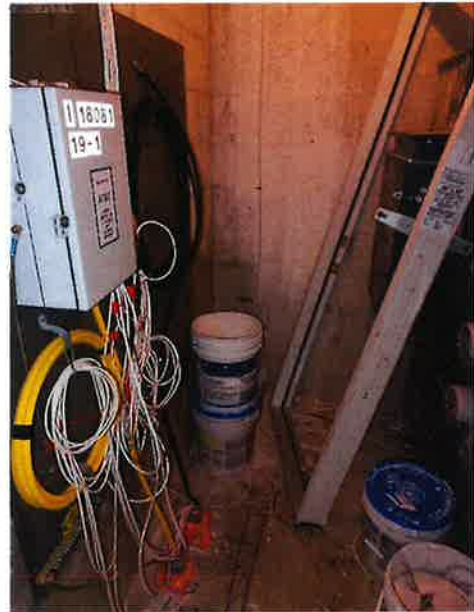
Photo # 4. Meter rooms were found use for storage purposes.

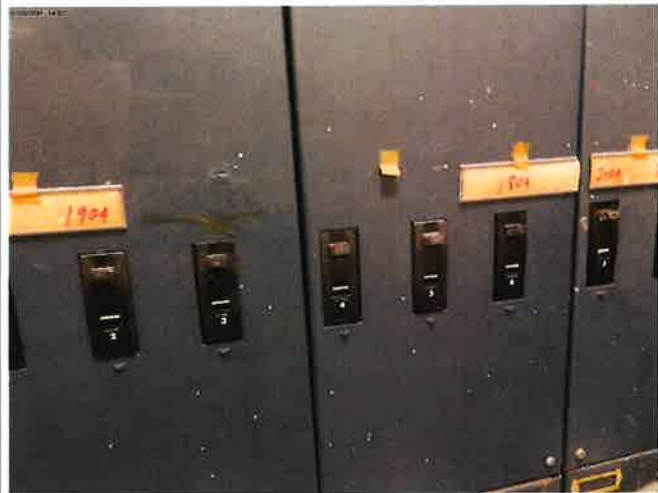
Photo # 5. Some main circuit breakers in the meter cans are missing identification of the unit they serve.

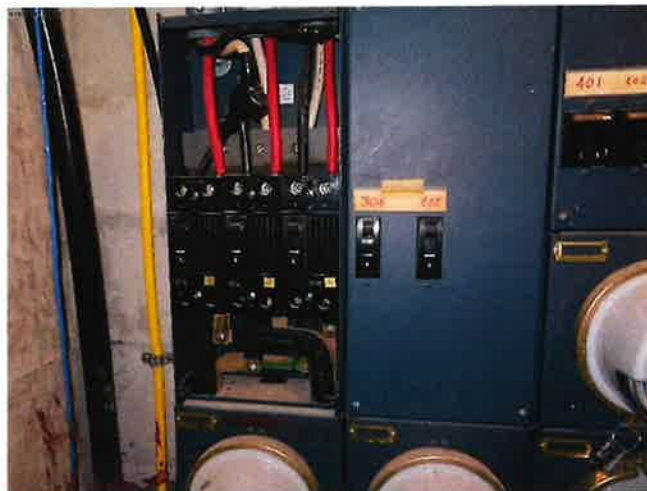
Photo # 6. North building tower 1, meter bank level 3: missing cover for meter can circuit breaker enclosure.

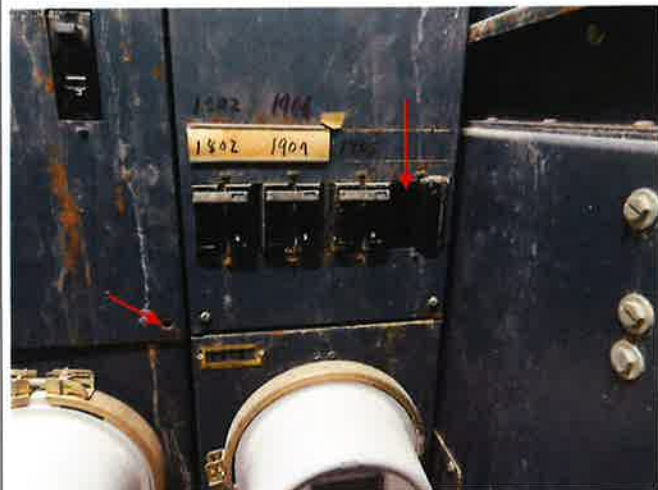
Photo # 7. North building, tower 3, meter room level 19: opening in meter can. Notice the circuit breaker cover is missing screws.

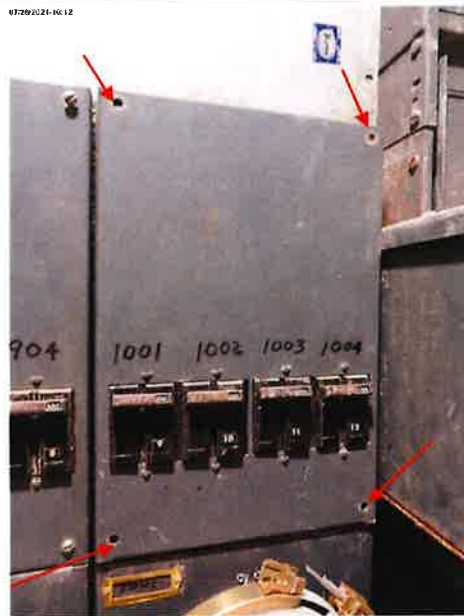
Photo # 8. North building, tower 3, meter room at level 9: circuit-breaker cover missing screws.

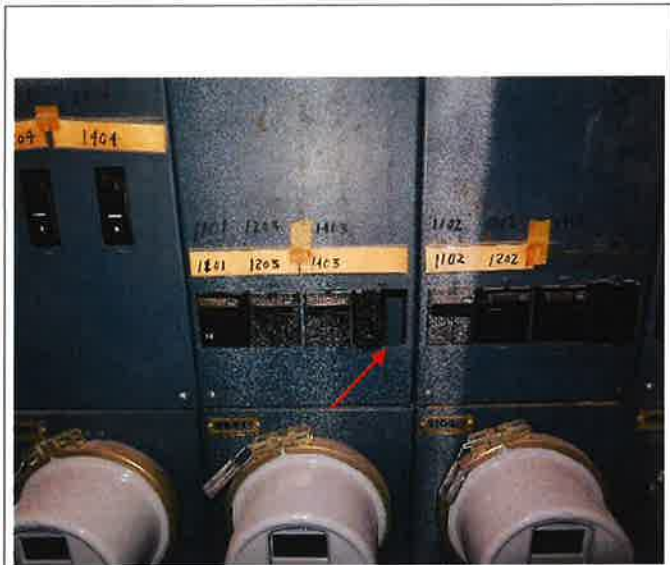
Photo # 9. North building, tower 4, meter room level 12: opening in circuit breaker space.

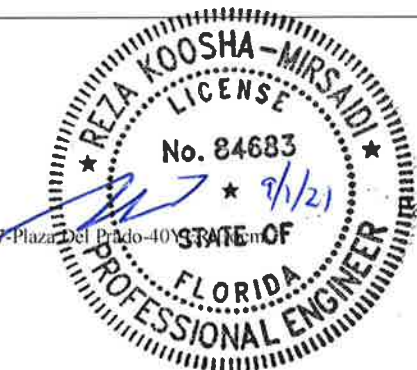
Photo # 12. Gutter in meter room level 3, North building, tower 1.

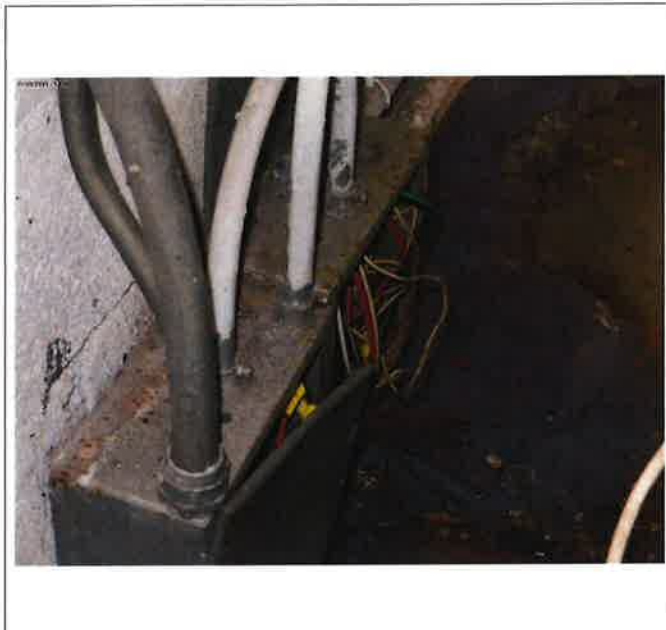
Photo # 13. Outside Air Unit 3N room: gutter missing cover.
