City of Aventura
 Community Development Department
 Building Division
 19200 W Country Club Drive
 Aventura, FL 33180
 305.466.8937 | permits@cityofaventura.com

NOTICE TO THE CITY OF AVENTURA BUILDING DIVISION OF EMPLOYMENT AS SPECIAL INSPECTOR UNDER THE FLORIDA BUILDING CODE

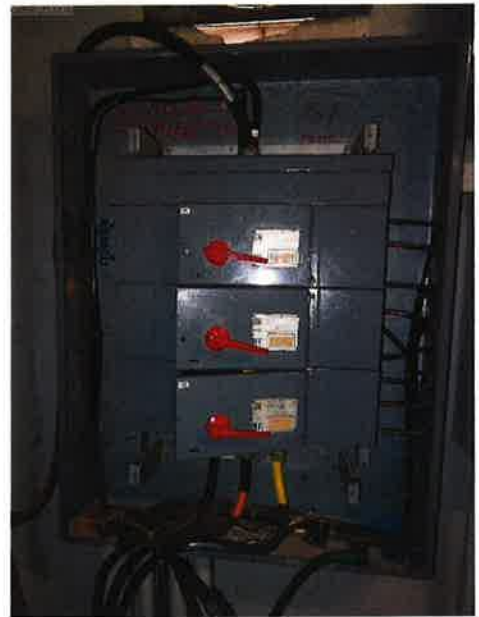
Photo # 14. North building main electrical room electrical panel depicted (item #4.1)

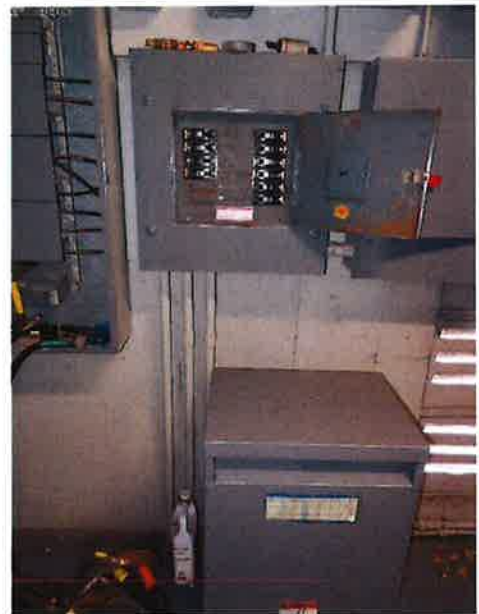
Photo # 16. North building main electrical room electrical panel depicted (item #4.2 "clearance violation")

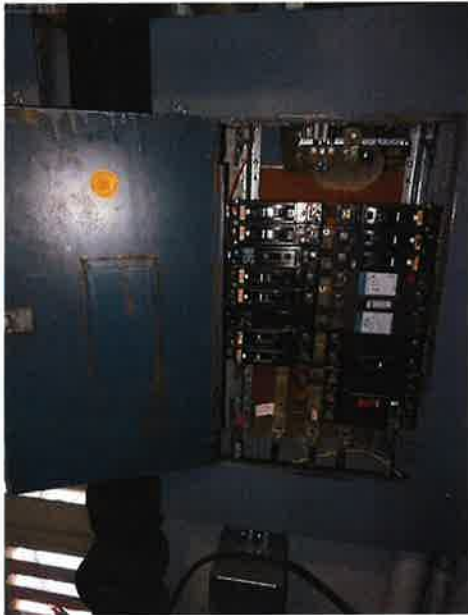
Photo # 17. North building main electrical room electrical panel depicted (item #4.3)

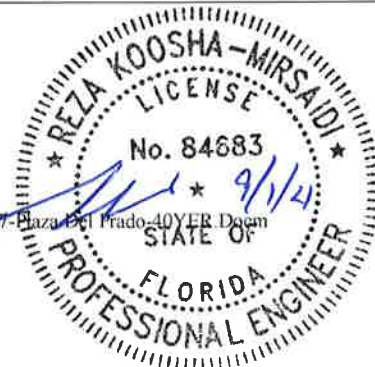
Photo # 88. Marina storage room (under the pool deck) – electrical panel depicted (item #4.70)

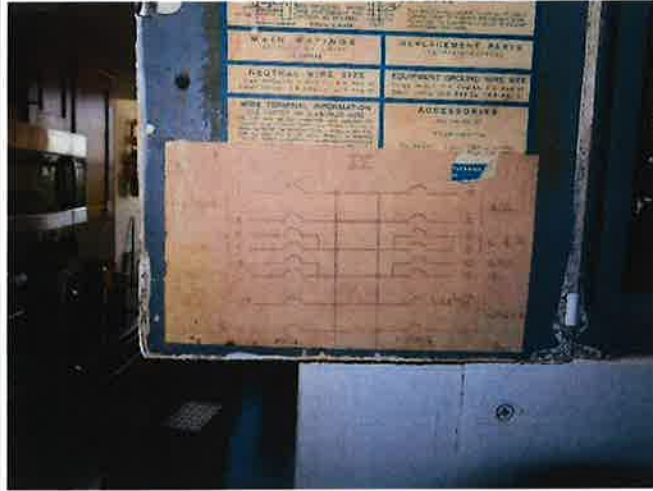
Photo # 89. Typical residential panel where the circuit directory is missing, incomplete or confusing (item #4.71)

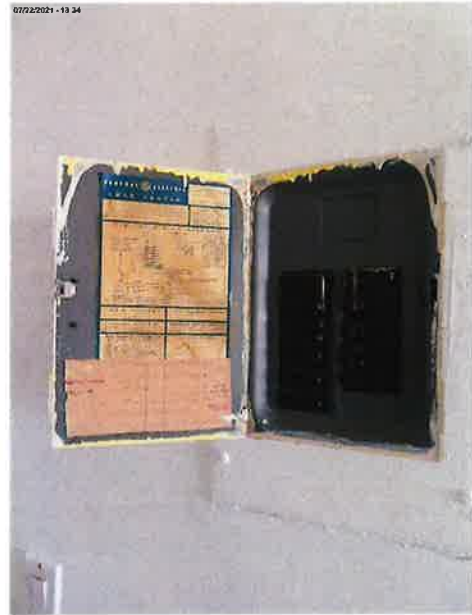
Photo # 90. Typical residential panel where the circuit directory is missing, incomplete or confusing (item #4.71)

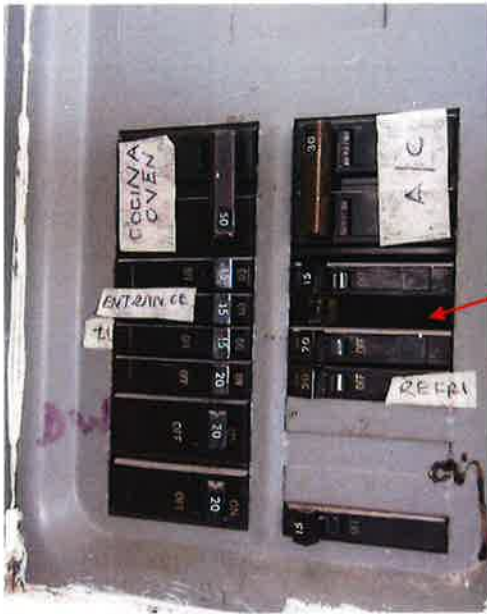
Photo # 91. Typical residential panel having an opening in a circuit space (item #4.71)

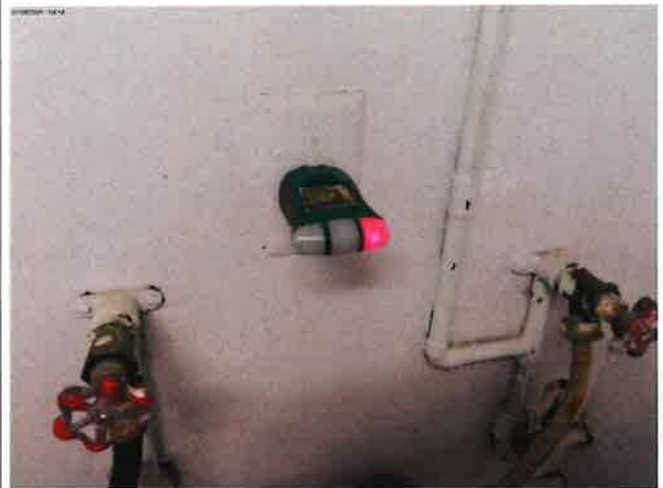
Photo # 96. Laundry room receptacle for the washer machine is depicted. Notice the grounding is missing. Also, GFCI protection is required (typical for all level, all towers in both buildings) (Item #10.b)

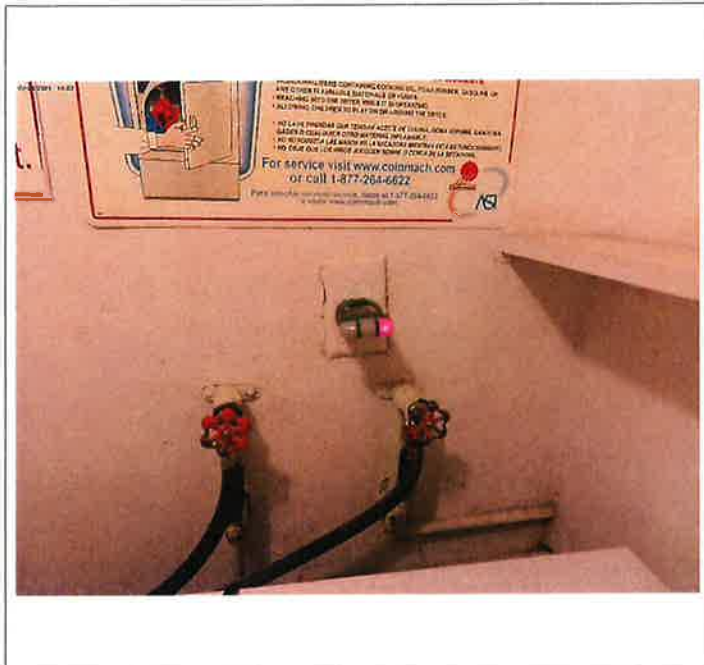
Photo # 97. Laundry room receptacle for the washer machine is depicted. Notice the grounding is missing. Also, GFCI protection is required (typical for all level, all towers in both buildings) (Item #10.b)

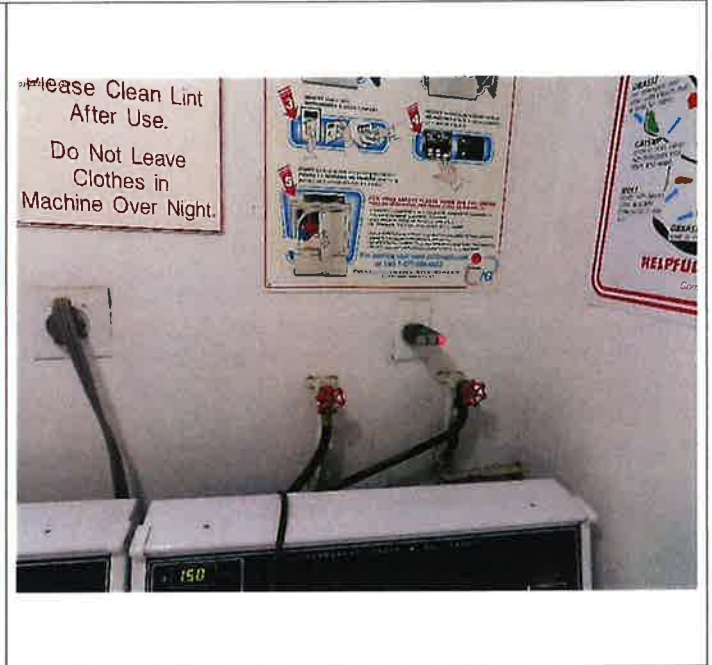
Photo # 98. Laundry room receptacle for the washer machine is depicted. Notice the grounding is missing. Also, GFCI protection is required (typical for all level, all towers in both buildings) (Item #10.b)

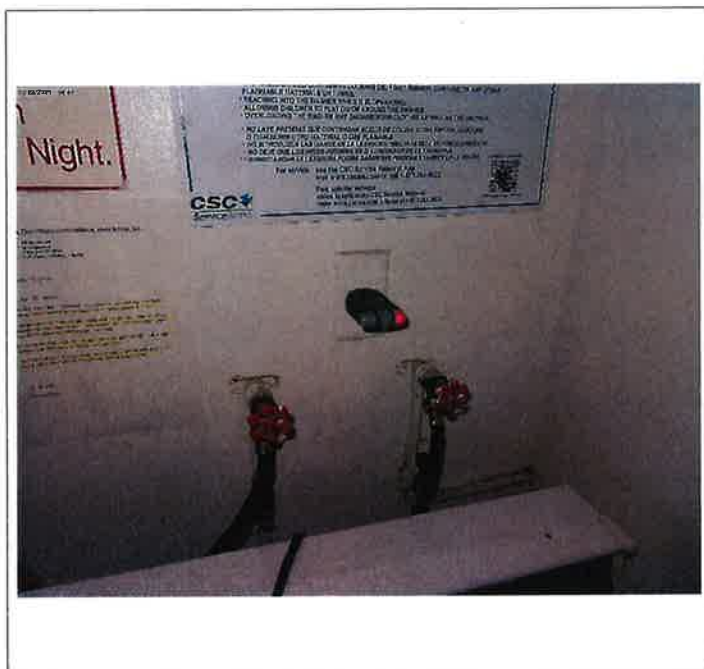
Photo # 99. Laundry room receptacle for the washer machine is depicted. Notice the grounding is missing. Also, GFCI protection is required (typical for all level, all towers in both buildings) (Item #10.b)

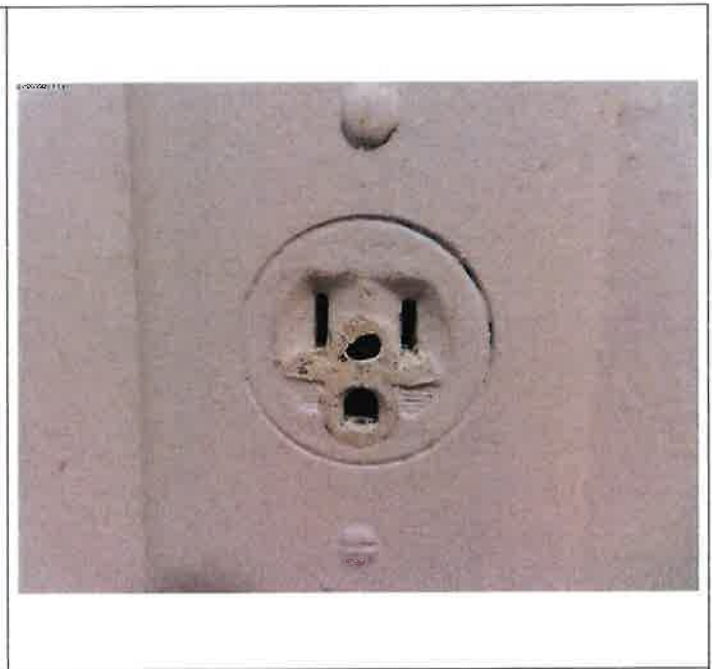
Photo # 100. Laundry room receptacle for the washer machine is depicted. Notice paint has penetrated the connection ports. Also, GFCI protection is required (Item #10.b)

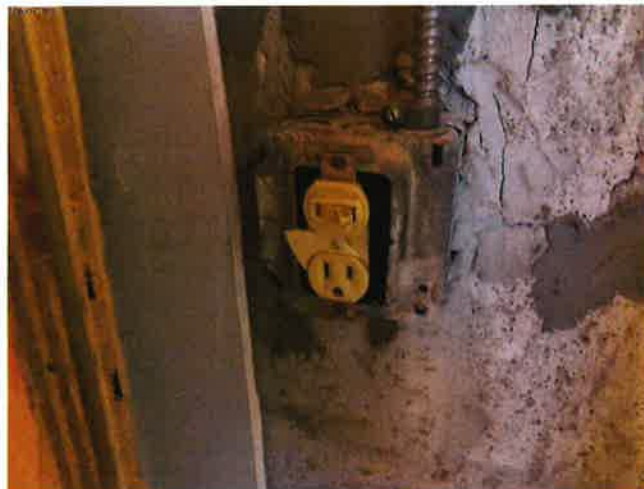
Photo # 102. North building, tower 3, PH level storage room: receptacle missing protective cover.

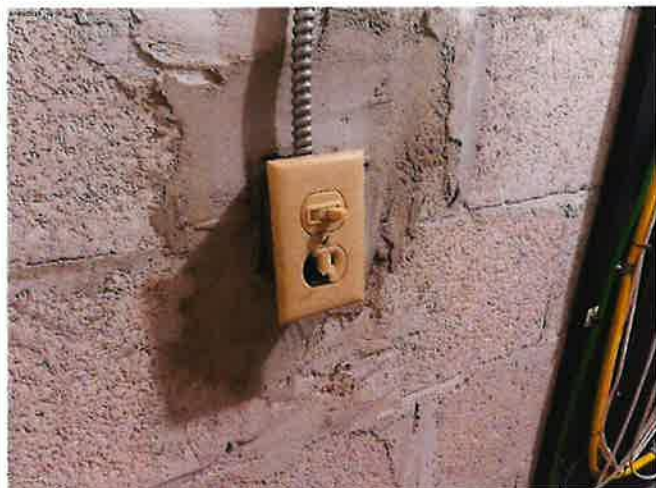
Photo # 103. Broken receptacle cover, meter room level 16, North building, tower 2.

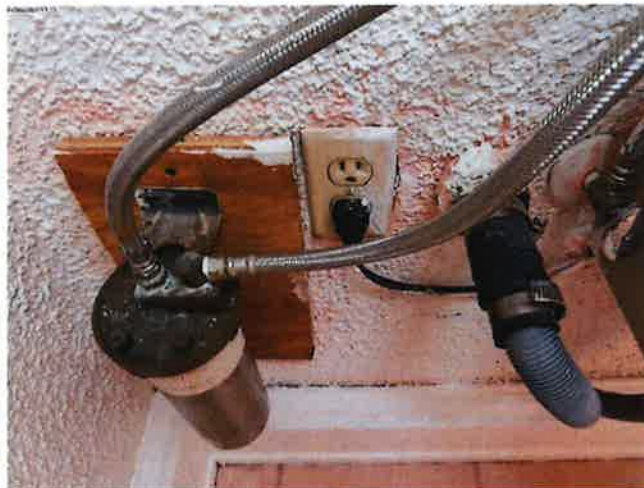
Photo # 104. Receptacle for the drinking water fountain must have GFCI protection.

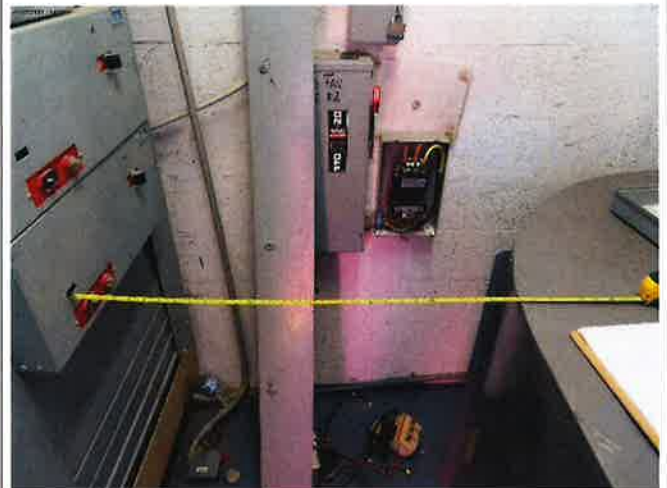
Photo # 124. Working space clearance violation (Item # 10-SOUTH-h)

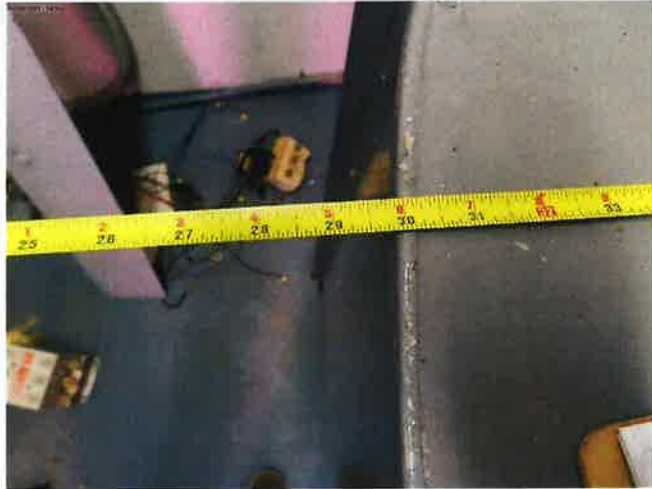
Photo # 125. Working space clearance violation (Item # 10-SOUTH-h)

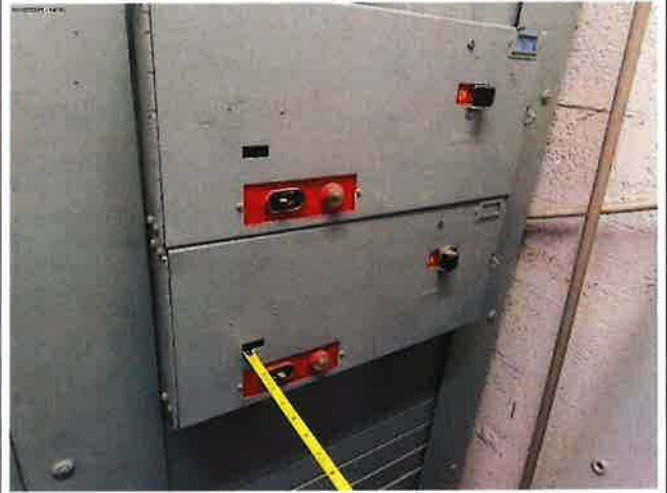
Photo # 126. Working space clearance violation (Item # 10-SOUTH-h)

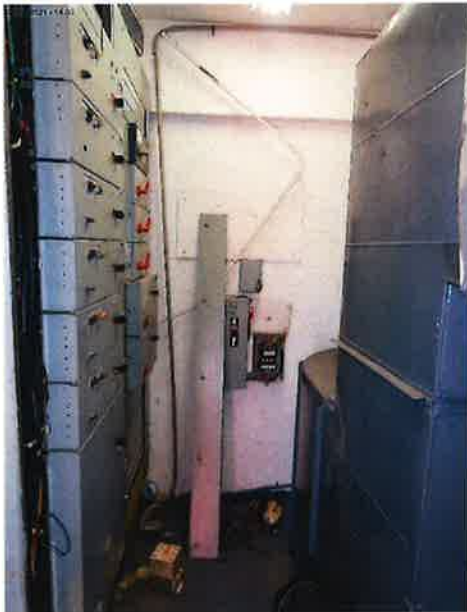
Photo # 127. Working space clearance violation (Item # 10-SOUTH-h)

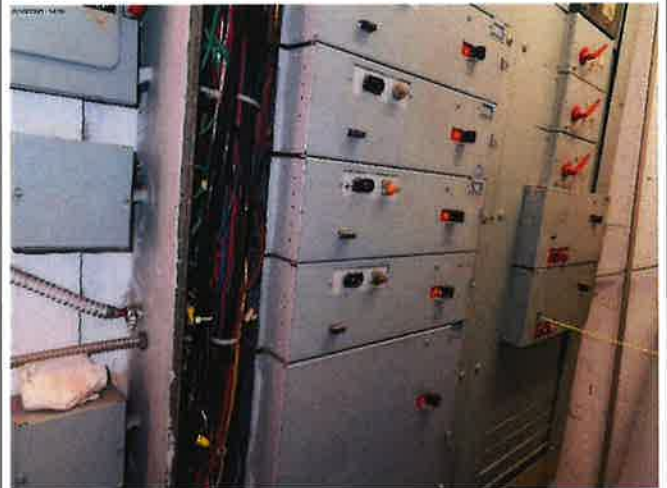
Photo # 128. Missing protective cover for the motor control center (Item # 10-SOUTH-i)

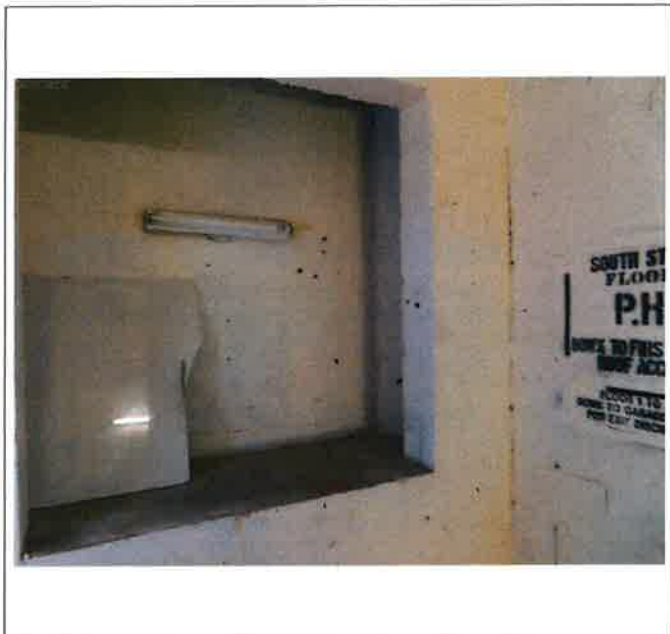
Photo # 129. Insufficient illumination for the building means of egress (Item #13.NORTH-a).

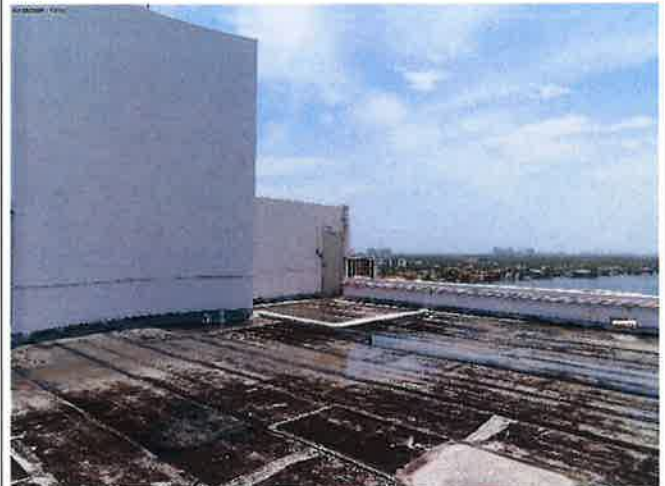
Photo # 140. North building roof: Stairwell exit doors are missing exit sign (Item # 16.a)

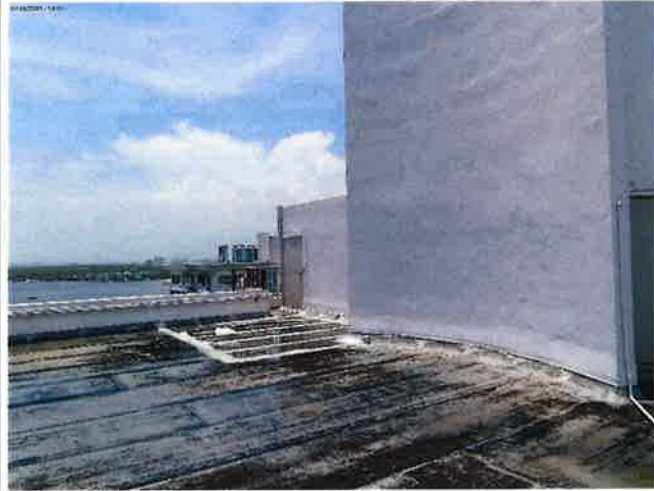
Photo # 141. North building roof: Stairwell exit doors are missing exit sign (Item # 16.a)

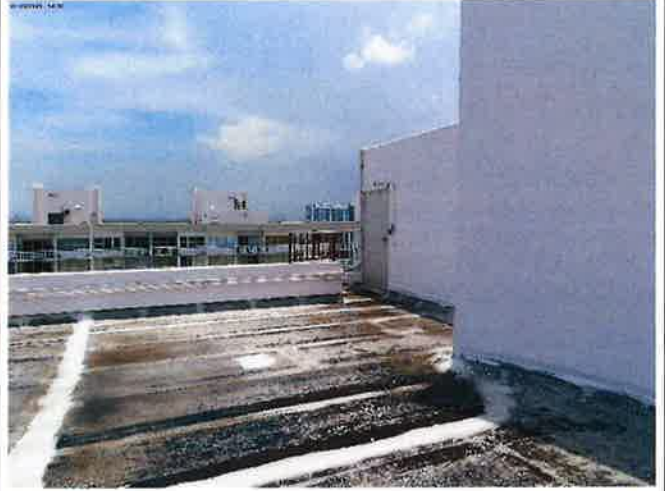
Photo # 142. North building roof: Stairwell exit doors are missing exit sign (Item # 16.a)

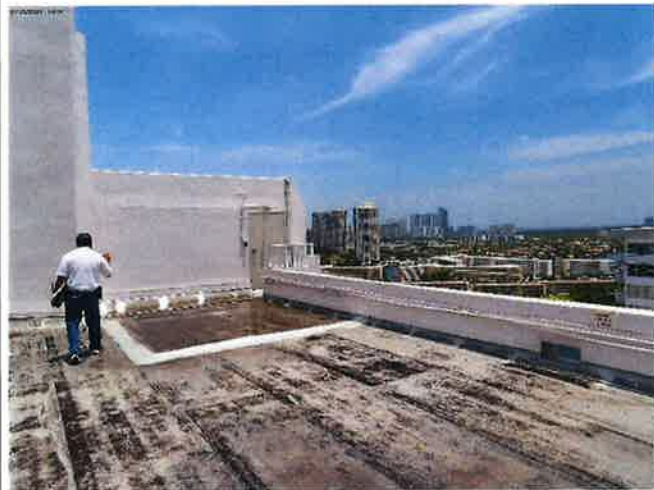
Photo # 143. North building roof: Stairwell exit doors are missing exit sign (Item # 16.a)

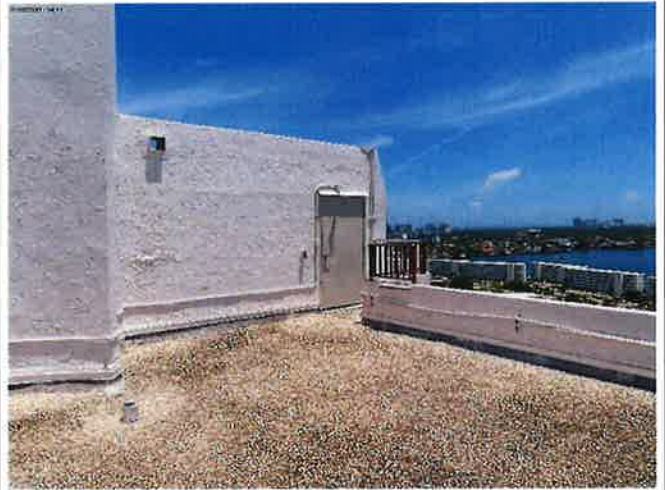
Photo # 144. South building roof: Stairwell exit doors are missing exit sign (Item # 16.b)

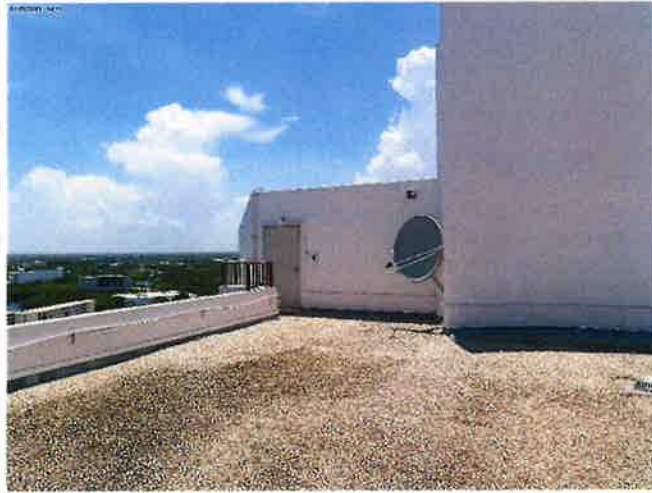
Photo # 145. South building roof: Stairwell exit doors are missing exit sign (Item # 16.b)

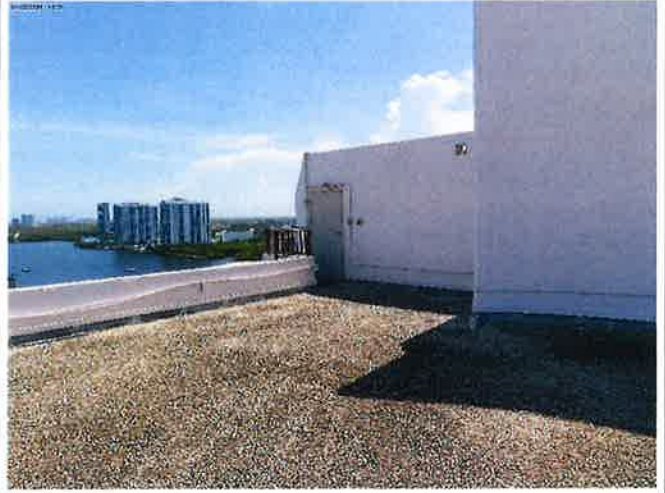
Photo # 146. South building roof: Stairwell exit doors are missing exit sign (Item # 16.b)

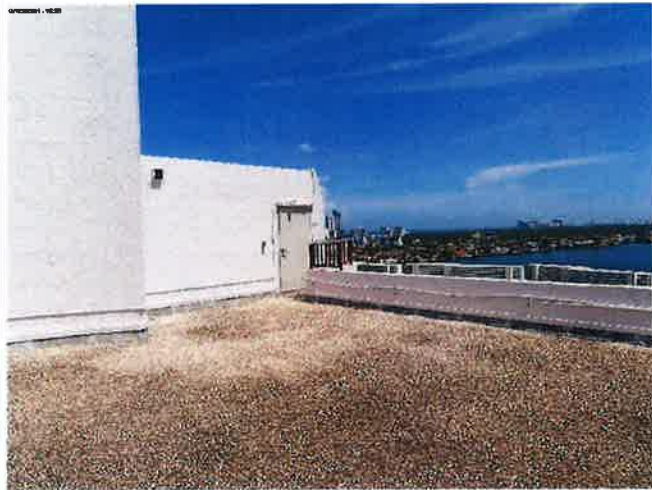
Photo # 147. South building roof: Stairwell exit doors are missing exit sign (Item # 16.b)

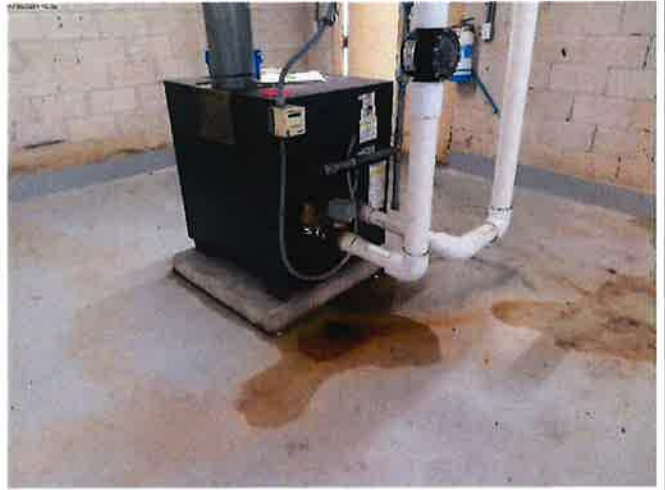
Photo # 148. Pool water heater not bonded. (Item # 20)
