Plaza Del Prado Condominium Association Inc.
18051 Biscayne Boulevard
Aventura, FL-33160

West Parking Garage Repaired Concrete Inspection
Phase I & Phase II

Narrative Statement wrt/ Concrete Repairs

Name: <u>Marcos Valdes</u>	Report Number: <u>06</u>
Client Name: <u>Plaza del Prado</u>	Visit Date: <u>12/03/2024</u>
Project Name: <u>Garage Deck Storm Drainage</u>	Visit Time: <u>01:00 PM</u>
Project Number: <u>16-637-031</u>	Ref: <u>None</u>

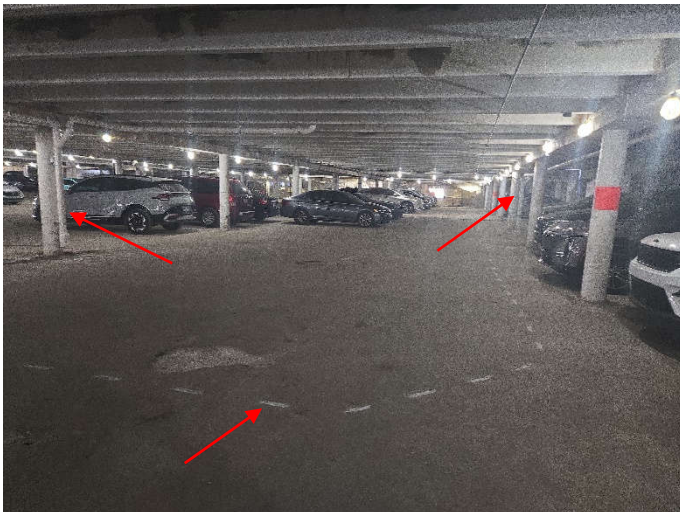
Photo # 3. Plaza del Prado, Garage Deck Storm Drainage, Downspout ND1 and ND2. Proposed underground layout.

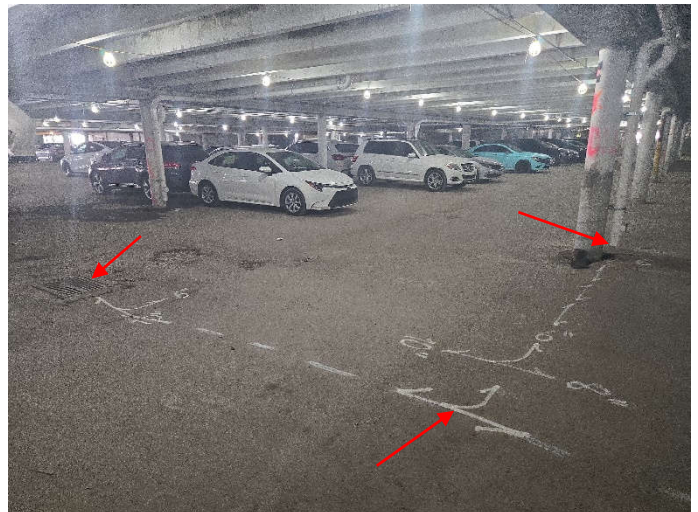
Photo # 4. Plaza del Prado, Garage Deck Storm Drainage, Downspout D11 and existing Catch Basin. Proposed underground layout.

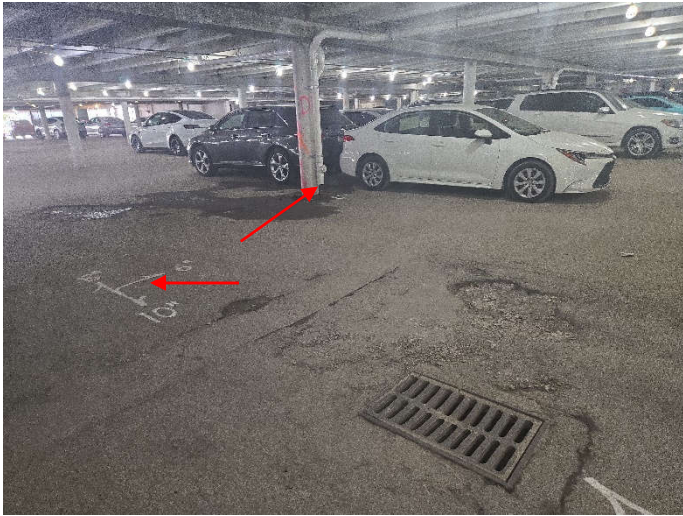
Photo # 5. Plaza del Prado, Garage Deck Storm Drainage, Downspout D10 and existing Catch Basin. Proposed underground layout
